## Annual Inspection

Lewes District Council

Glynde Play Area

The Street, Glynde, BN8 6SS

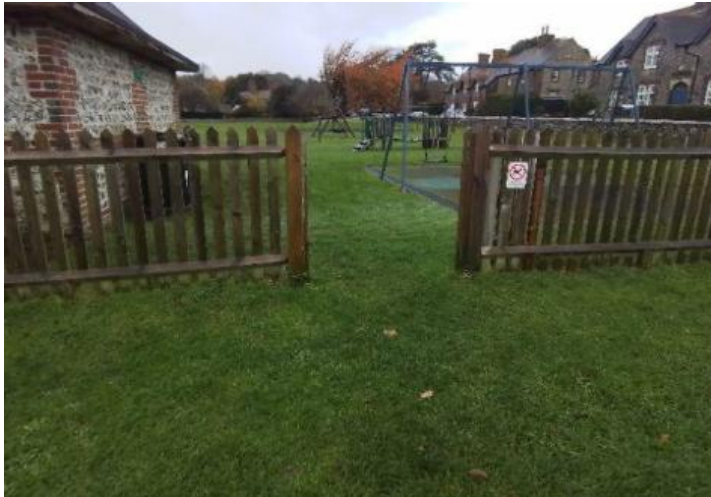
**Finding:** It is recommended that signage, with information including the site address, contact information for maintenance issues and emergency contact details are provided for the facility

**Action:** Provide in accordance with the recommendations

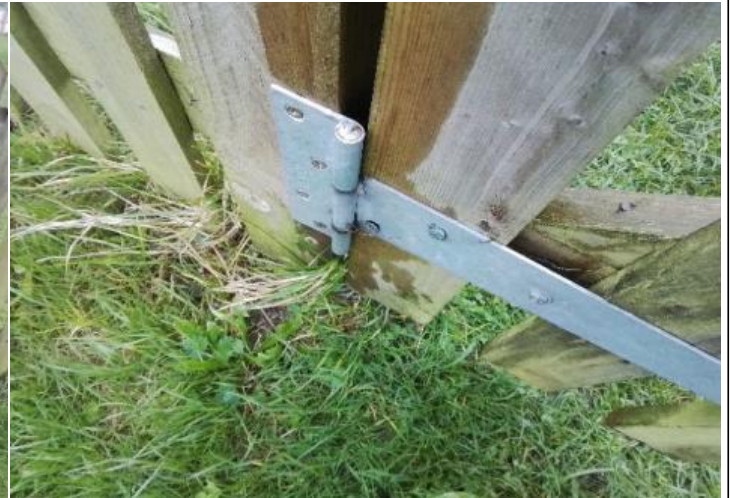
**Finding:** A number of fixing(s) have worked loose

**Action:** Secure all loose fixings

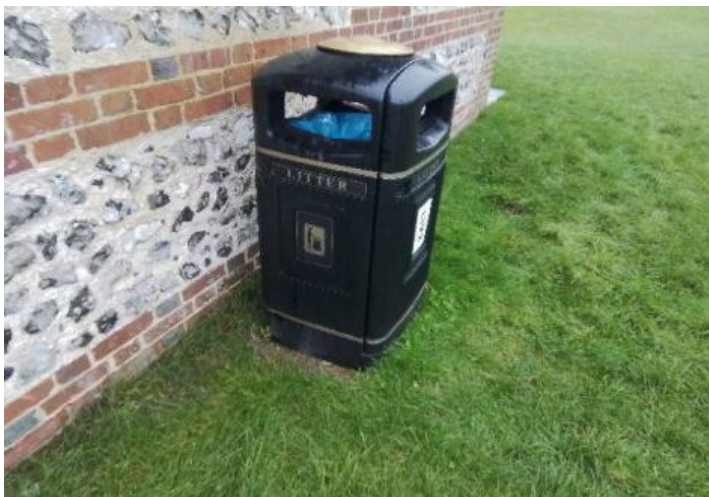
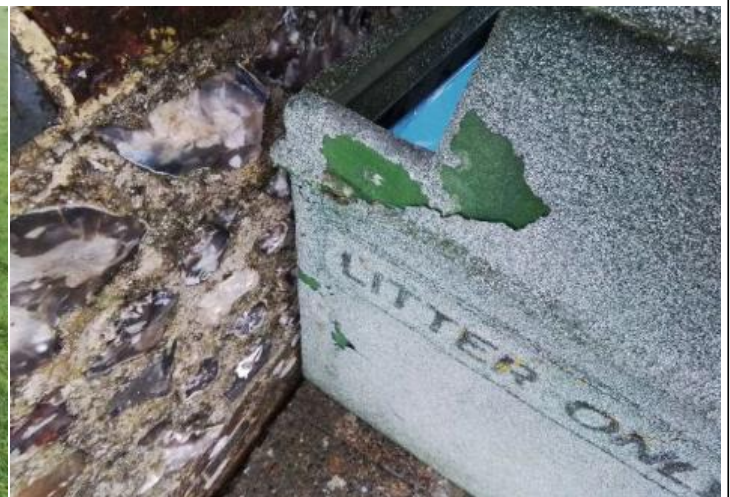
**Finding:** There is some damage to the bin

**Action:** Monitor for any further deterioration and replace as required

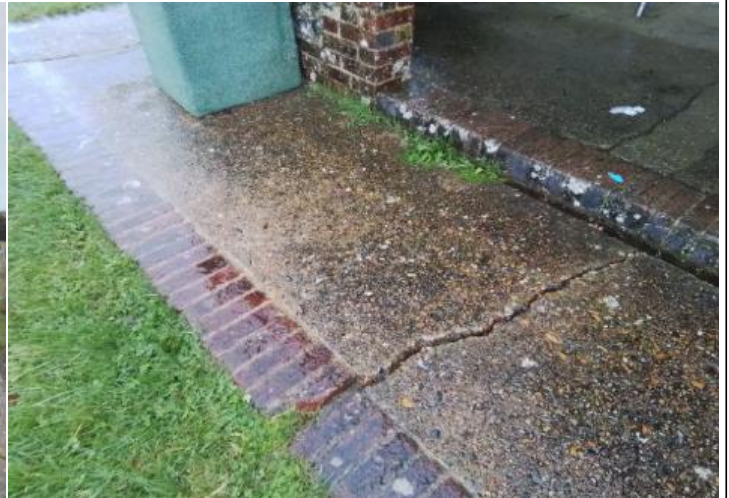
**Finding:** The concrete pad is damaged

**Action:** Repair affected areas

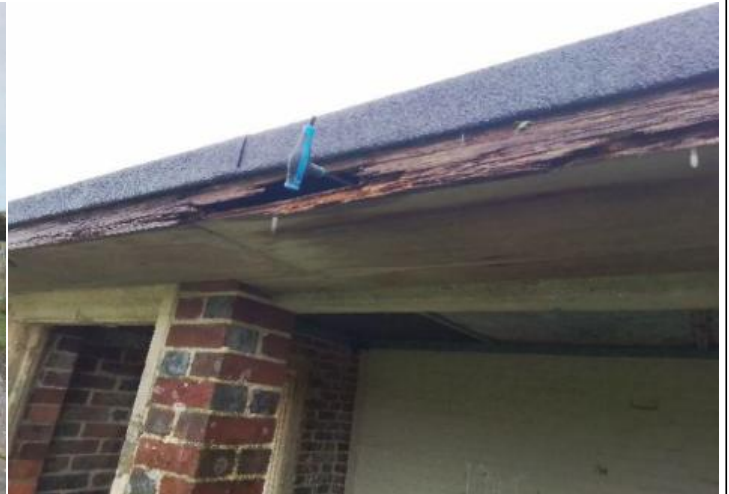
**Finding:** There are areas or parts of the roof timbers that have rotted

**Action:** Replace all affected timbers

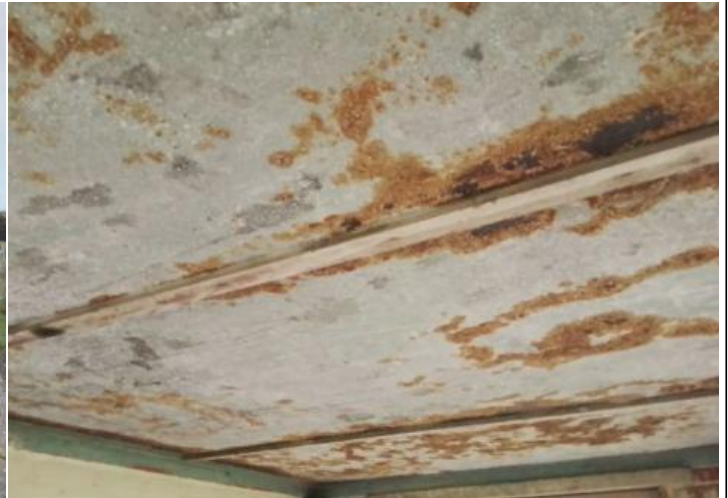
**Finding:** There is surface corrosion / rust present on the item

**Action:** Consider treating the item

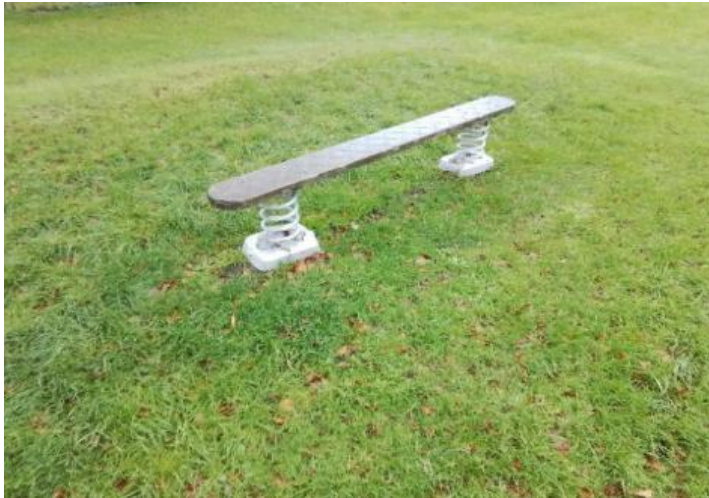
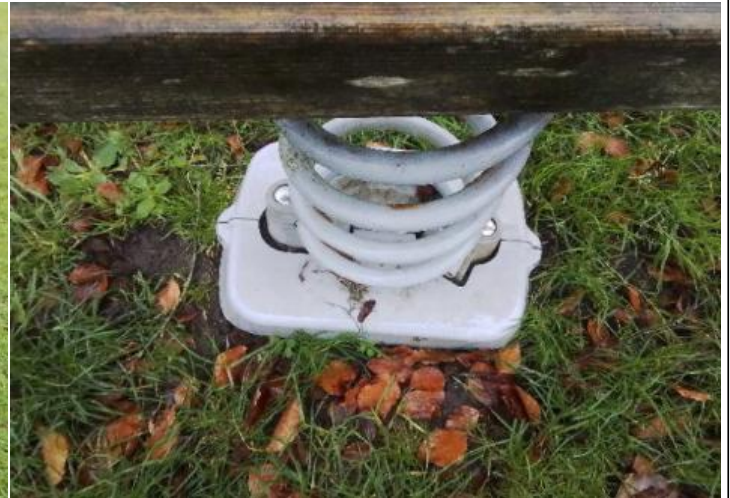
**Finding:** The paintwork on the spring has been damaged or worn exposing the metal underneath which is rusting **Action:** Treat any rusting components and repaint

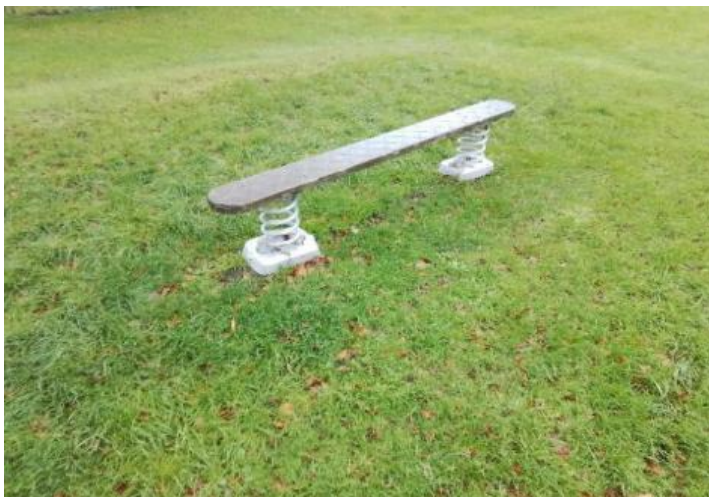
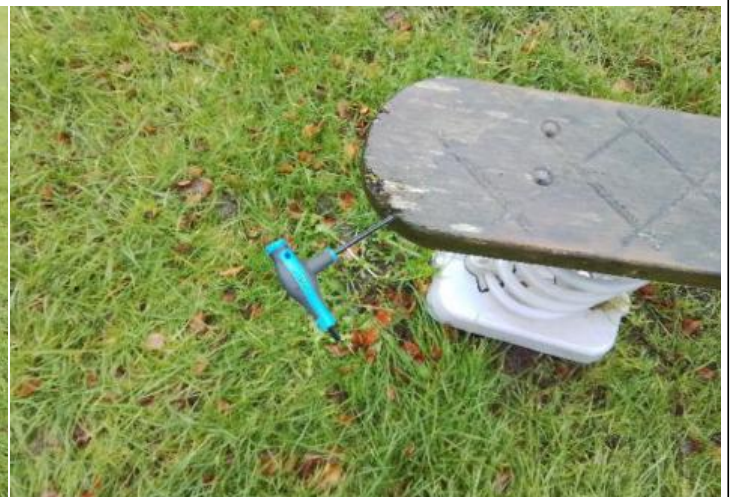
**Finding:** There is some evidence of rot in the timber **Action:** Monitor for any further deterioration and replace as required

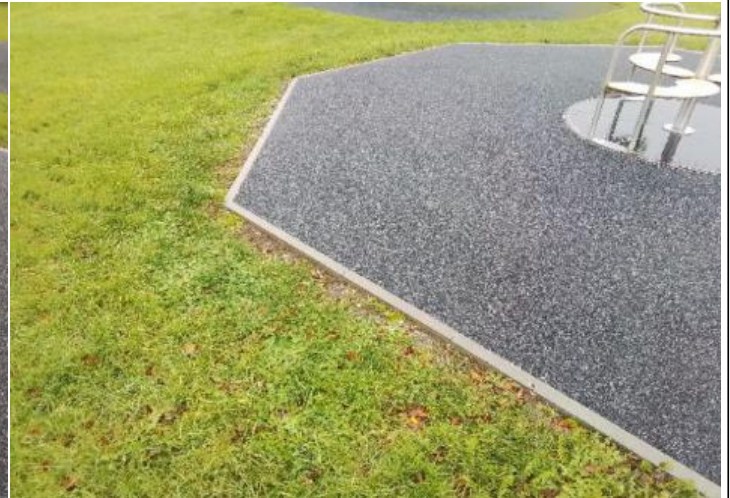
**Finding:** There are trip hazards at the edges of the surface

**Action:** Reinstate surrounding surface levels to remove the trip points

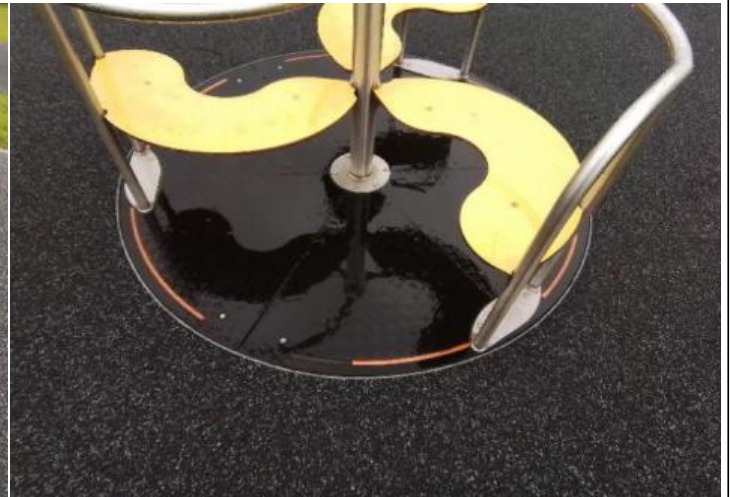
**Finding:** The bearing is worn / damaged and the item is not operating correctly

**Action:** Repair / replace

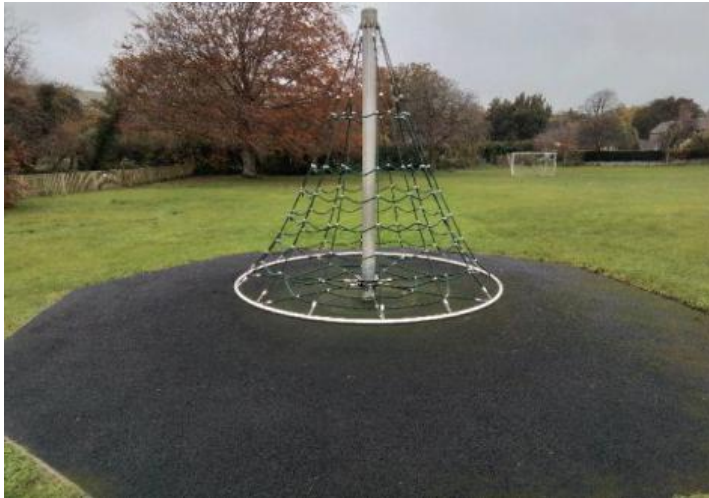
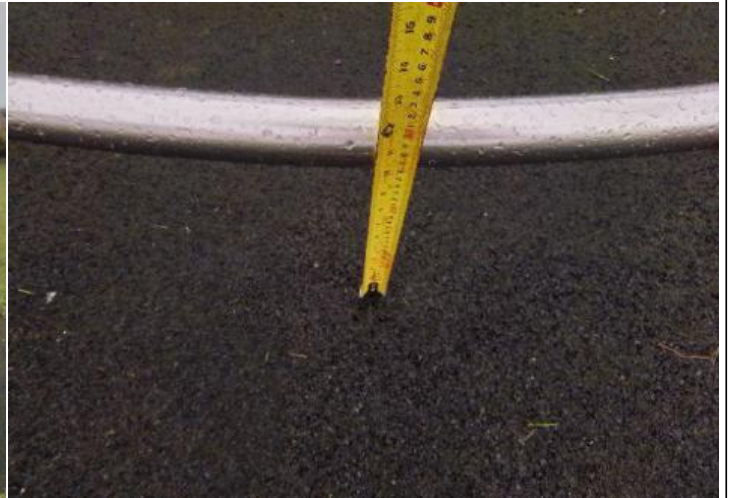
**Finding:** The height to the underside of the rim is less than 400mm and fails the requirements of BS EN 1176 Part 5

**Action:** Monitor - No remedial work recommended

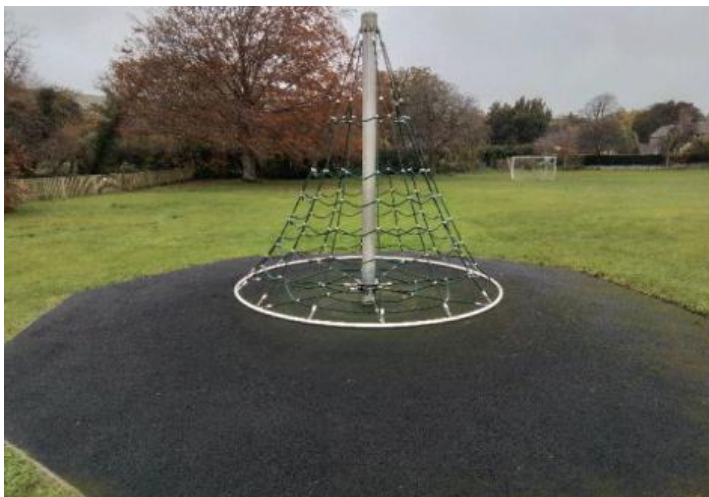
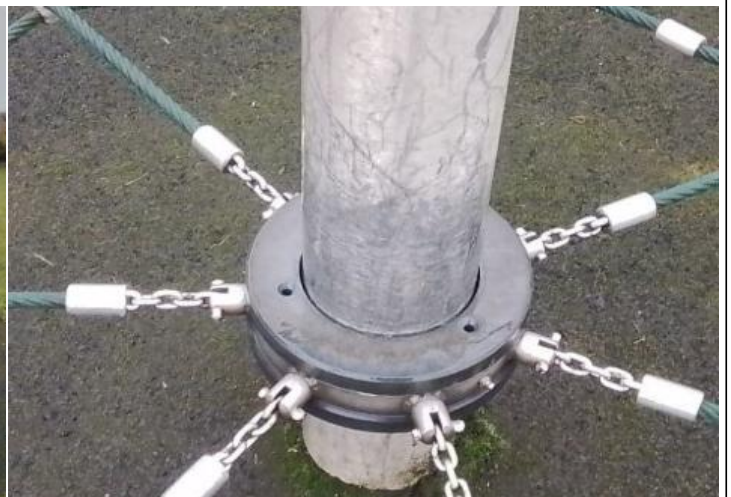
**Finding:** There is or are fixings missing on the item

**Action:** Replace all missing fixings

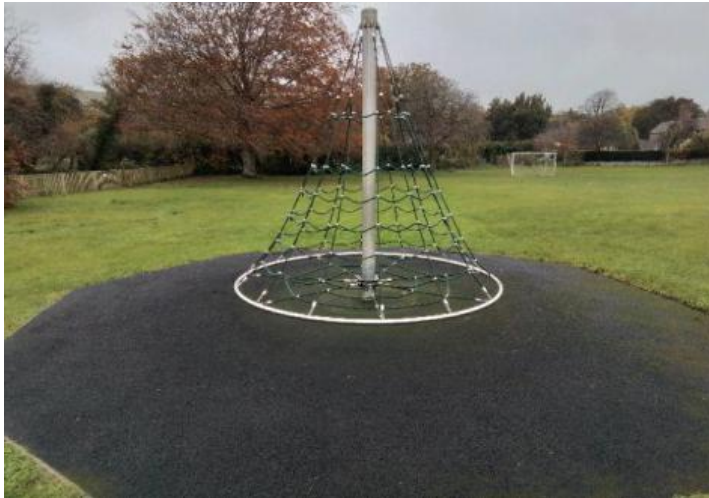
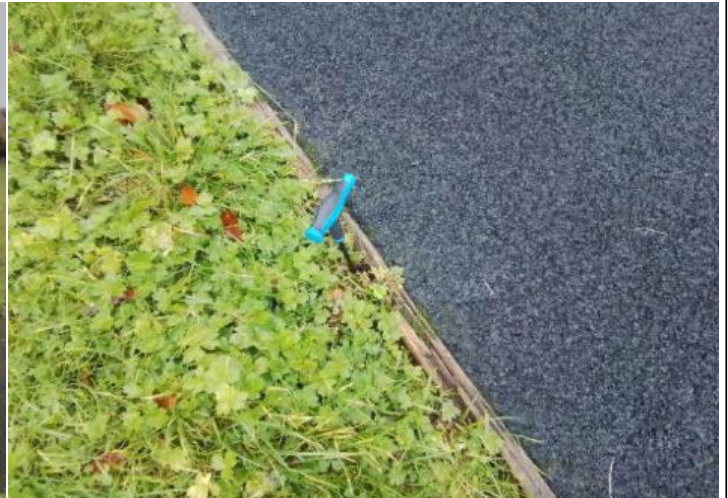
**Finding:** There are areas or parts of the timber edging surrounding the play equipment that have rotted

**Action:** Replace all affected timbers

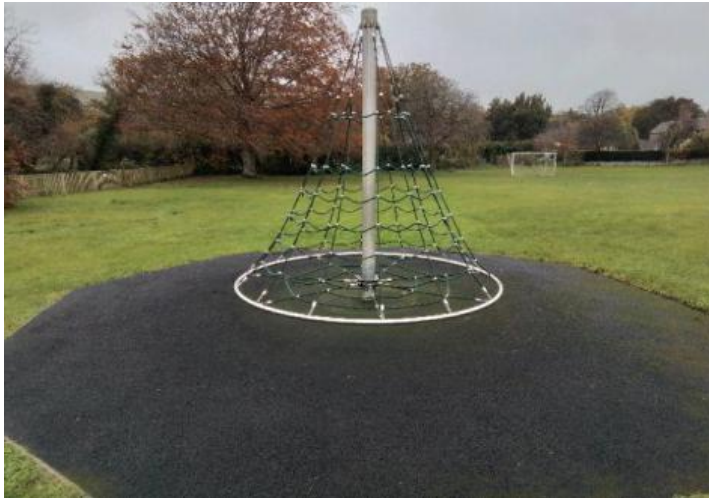
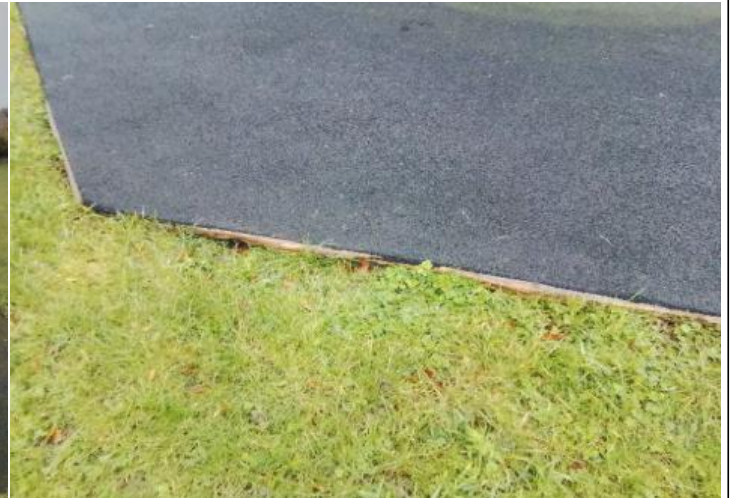
**Finding:** There are trip hazards at the edges of the surface

**Action:** Reinstate surrounding surface levels to remove the trip points

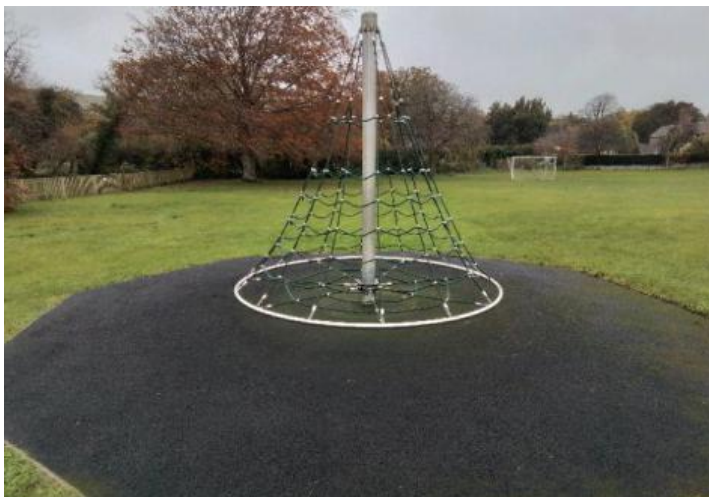
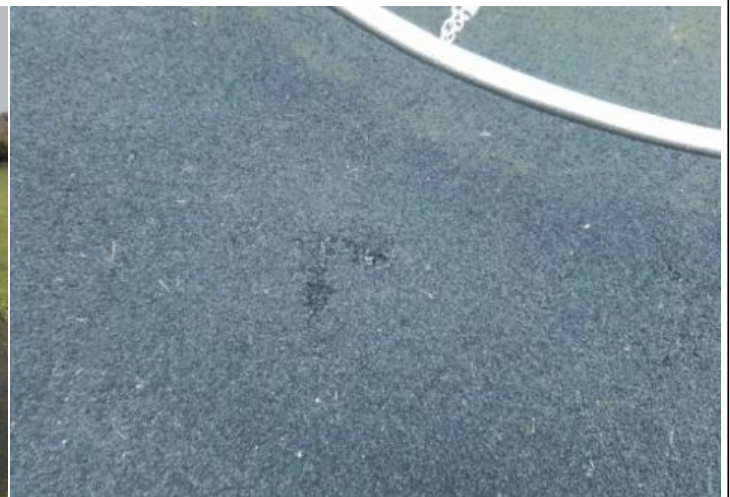
**Finding:** There is some minor damage to the surface

**Action:** Monitor for any further deterioration and repair as required

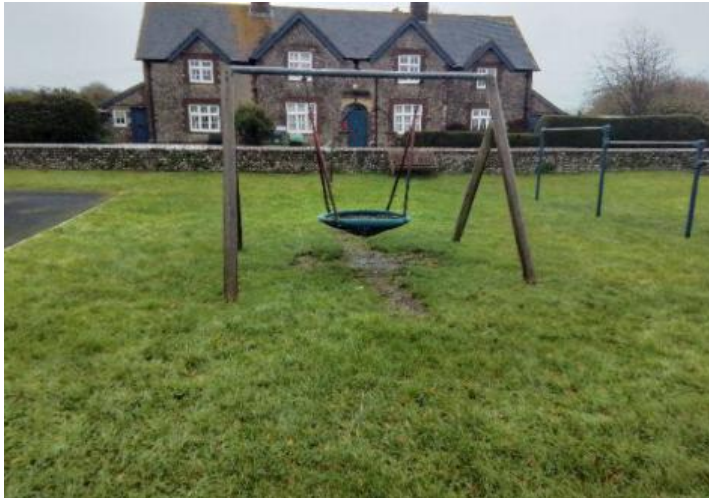
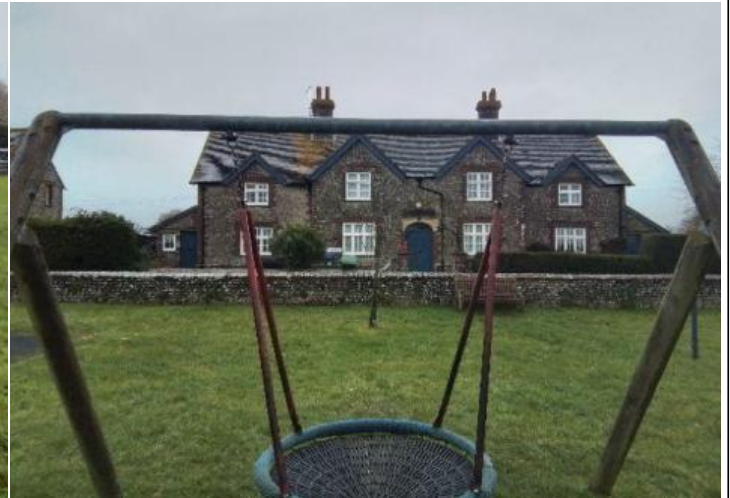
**Finding:** Swings of this design should have a secondary safety mechanism fitted to prevent collapse of the seat in the regularly event of a joint failure to comply with BS EN 1176 Part 2, however this swing was installed prior to the standards being updated in 2018 and the manufacturer has confirmed that the joint was independently cycle tested by BSi

**Action:** Monitor use and check the joint and fixing security

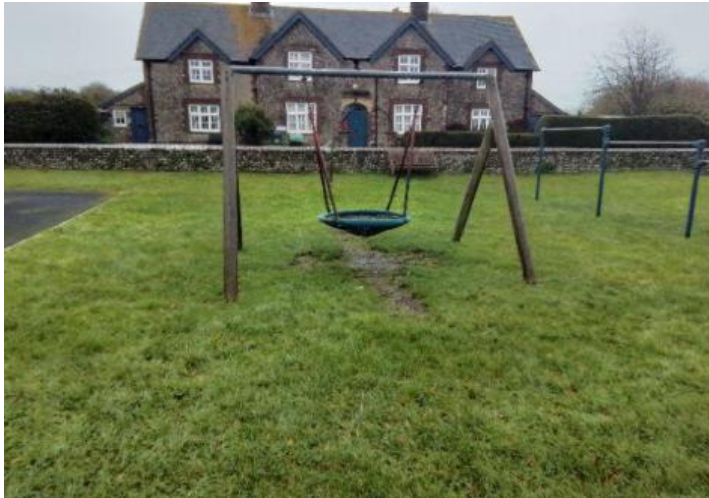
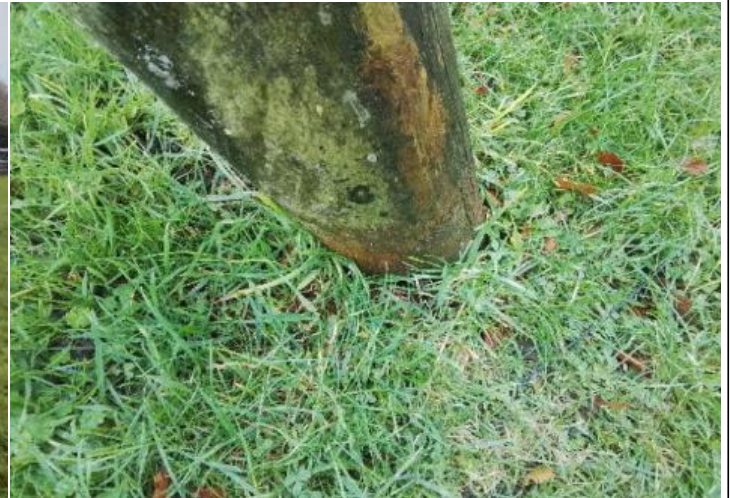
**Finding:** There is some strimmer / machinery damage apparent on the posts, this can penetrate the preservative applied to the timber and accelerate the rotting process

**Action:** Monitor for any deterioration (rot) and replace as required

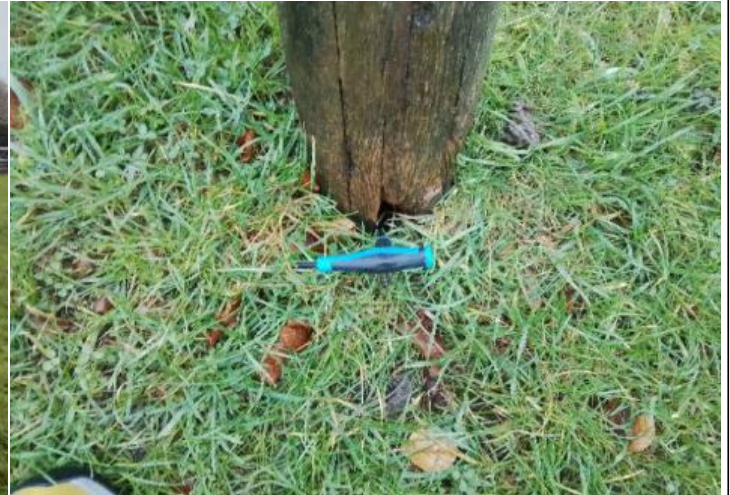
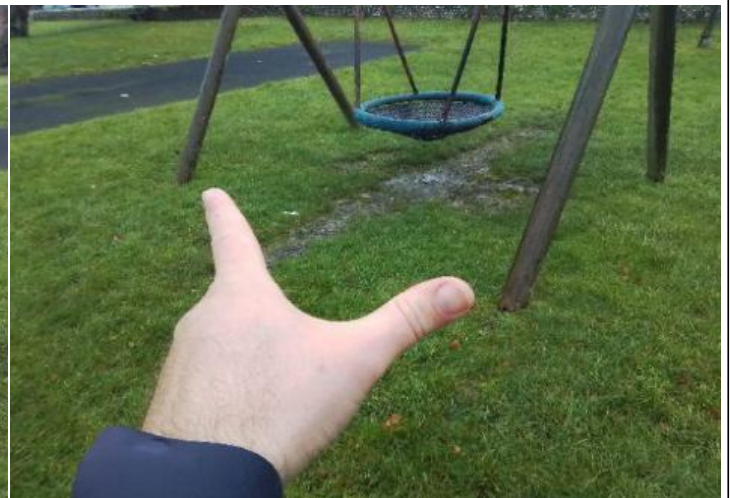
**Finding:** There are areas or parts of the posts x4 on the structure that have rotted

**Action:** Replace all affected timbers

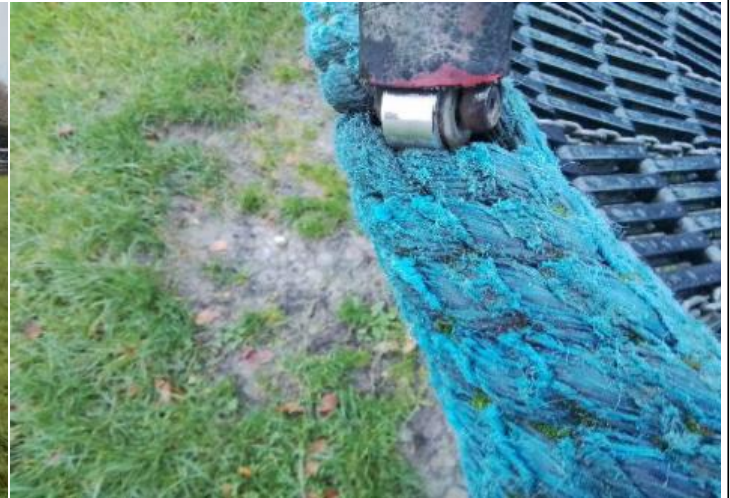
**Finding:** The seat bushes are showing signs of wear

**Action:** Monitor for any further deterioration and replace as required

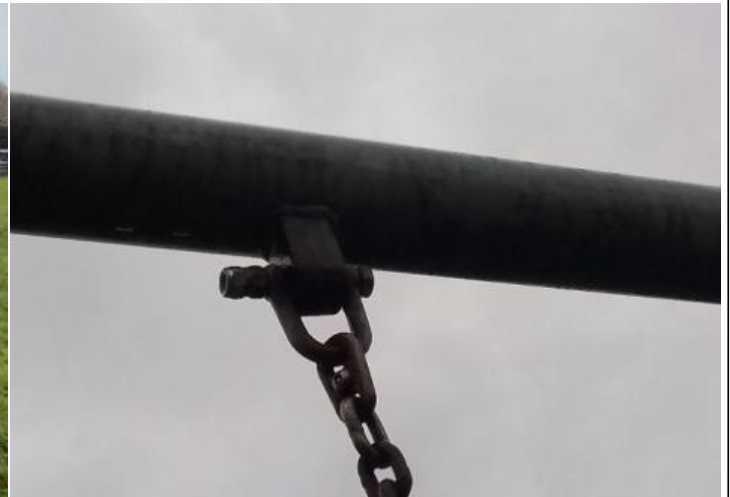
**Finding:** The bushes are showing signs of wear

**Action:** Monitor for any further deterioration and replace as required

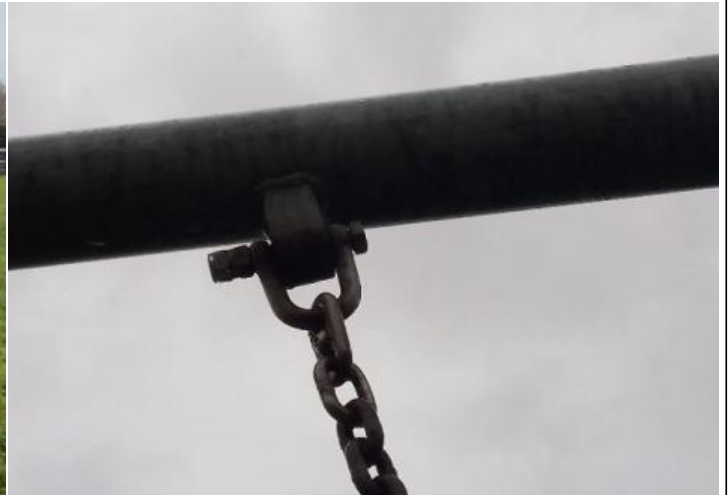
**Finding:** There is some notable evidence of chain wear

**Action:** Monitor for any further deterioration and replace when 40% worn

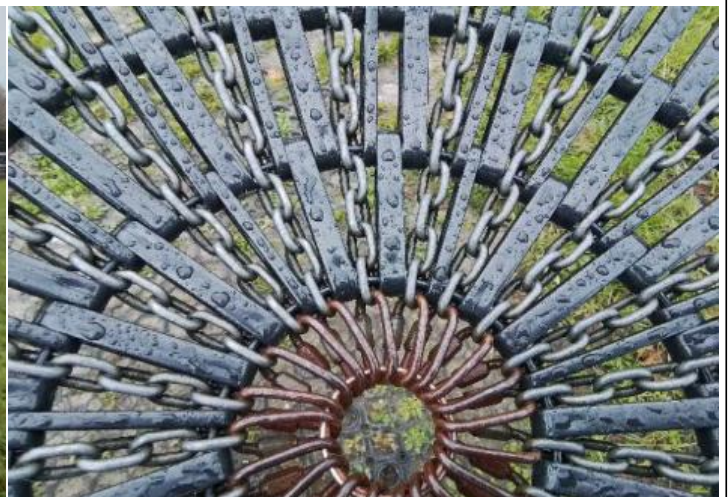
**Finding:** There is some wear to the connecting links

**Action:** Monitor for any further deterioration and replace when 40% worn

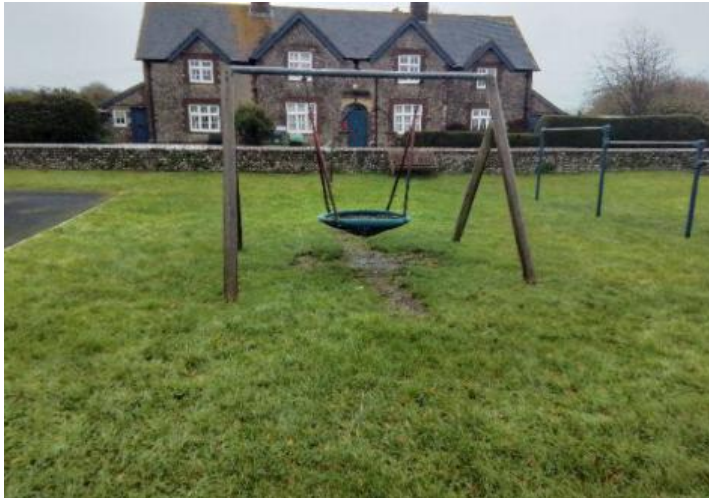
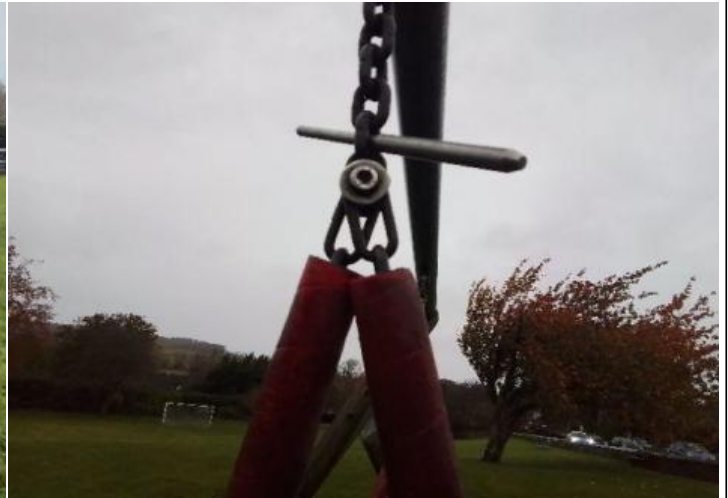
**Finding:** The chain openings are in excess of the 8.6mm as recommended by BS EN 1176 **Action:** Monitor - No remedial work recommended

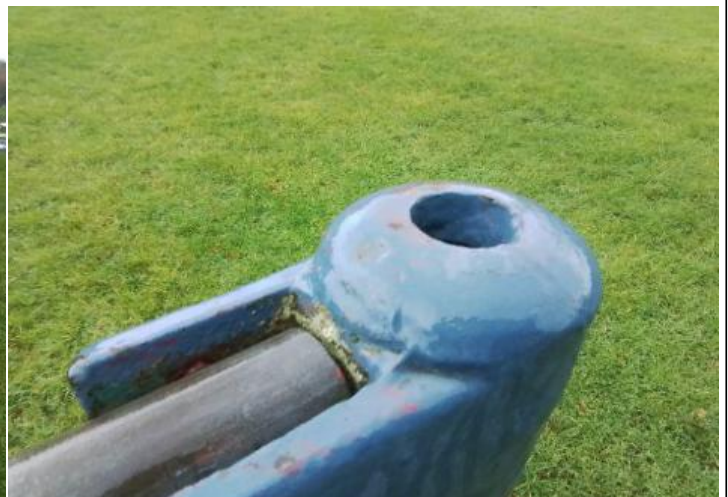
**Finding:** There are post / end caps missing from the item

**Action:** Replace missing post caps

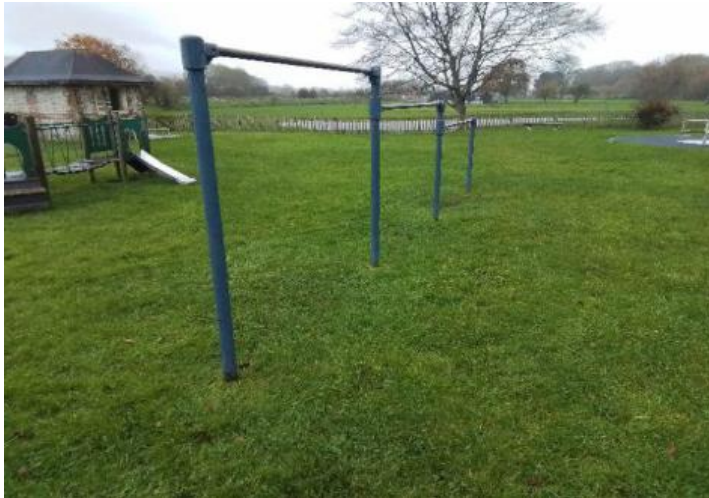
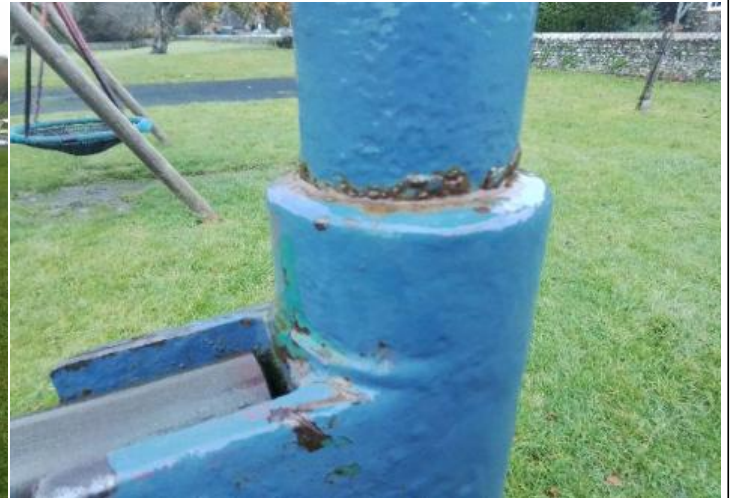
**Finding:** The paintwork on this item has been damaged or worn exposing the metal underneath which is rusting / corroding

**Action:** Treat affected areas and repaint

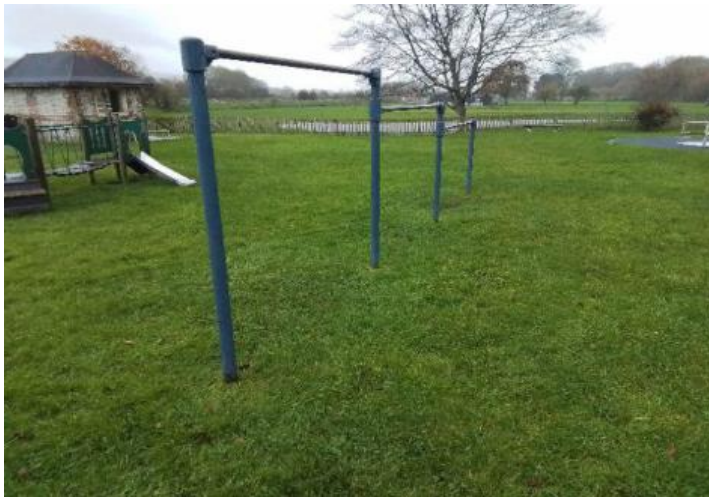
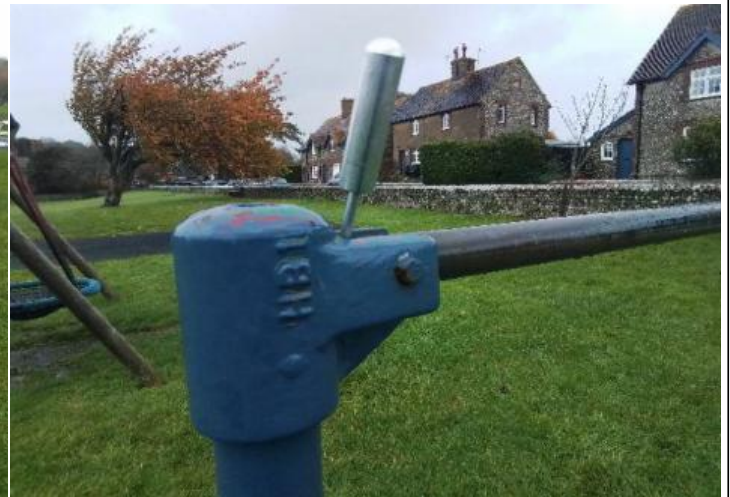
**Finding:** There is/are finger entrapment/s in the framework and the item fails to meet the requirements of BS EN 1176 Part 1 4.2.7.6 Entrapment of fingers

**Action:** Monitor - No remedial work recommended

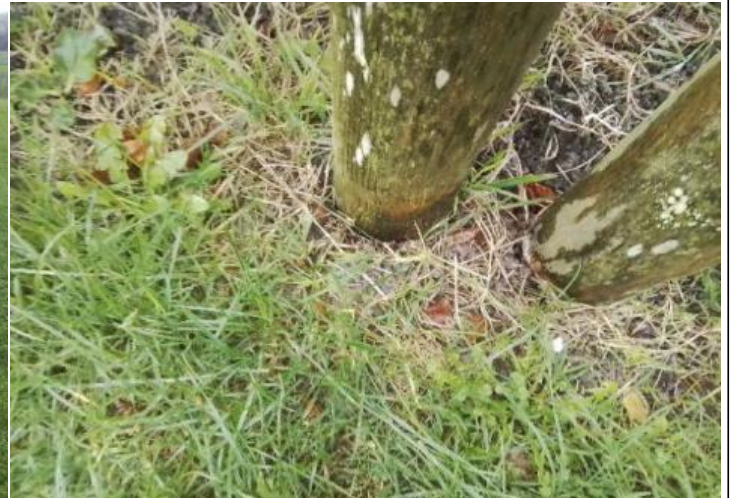
**Finding:** There is some strimmer / machinery damage apparent on the posts, this can penetrate the preservative applied to the timber and accelerate the rotting process

**Action:** Monitor for any deterioration (rot) and replace as required

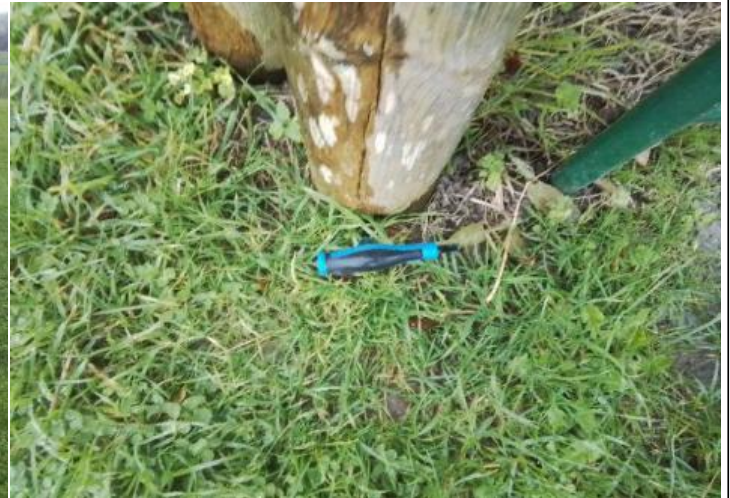
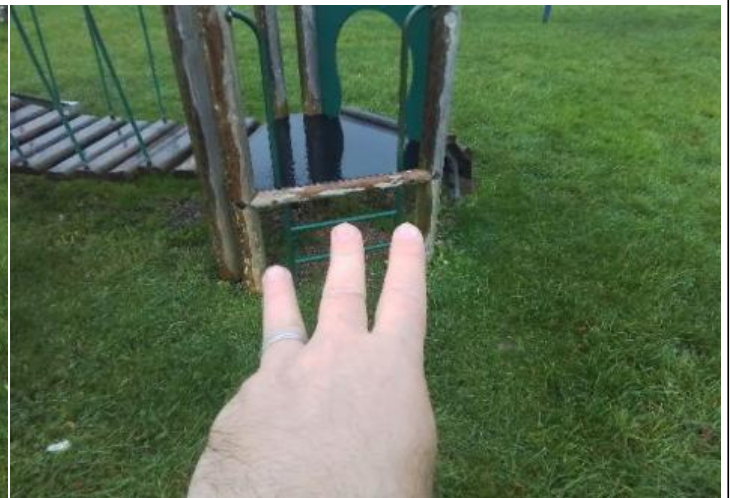
**Finding:** There are areas or parts of the posts x6 on the structure that have rotted with evidence of rot in the remaining posts

**Action:** Replace all affected timbers

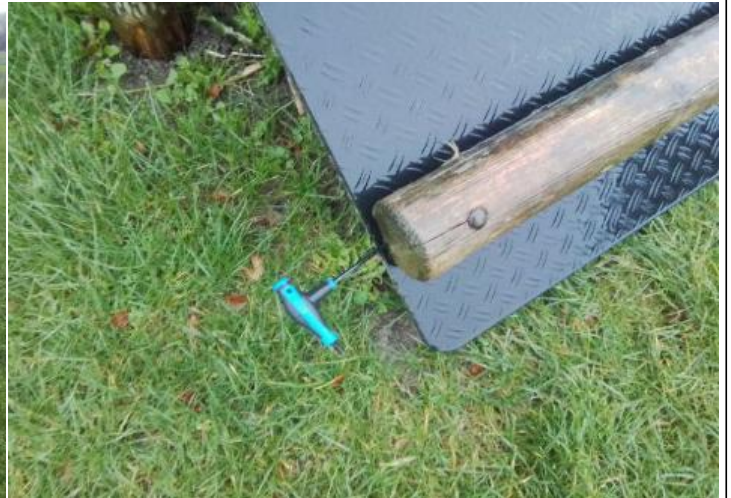
**Finding:** There is some evidence of rot in the timber

**Action:** Monitor for any further deterioration and replace as required

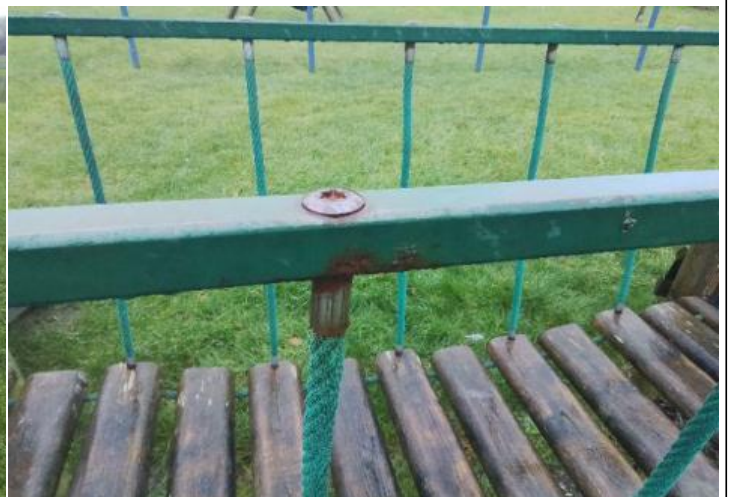
**Finding:** The paintwork on this item has been damaged or worn exposing the metal underneath which is rusting / corroding

**Action:** Treat affected areas and repaint

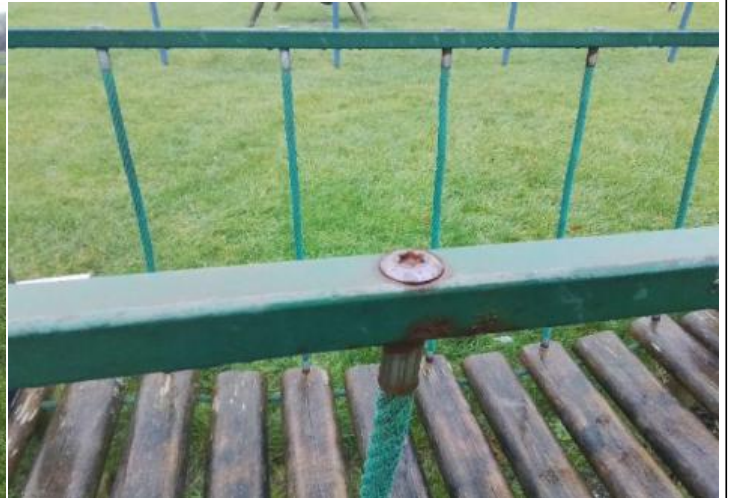
**Finding:** A number of rope fixing(s) have worked loose

**Action:** Secure all loose fixings

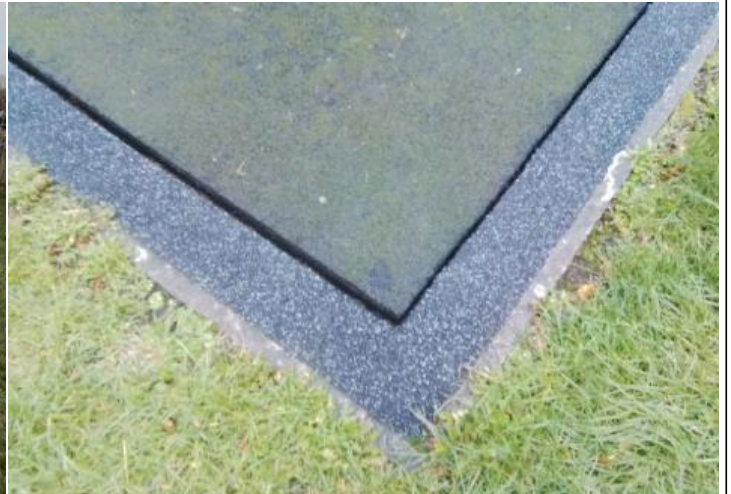
**Finding:** There are gaps opening between the surfacing and the edging surround or between the joints in the surfacing

**Action:** Monitor for any further deterioration and repair as required

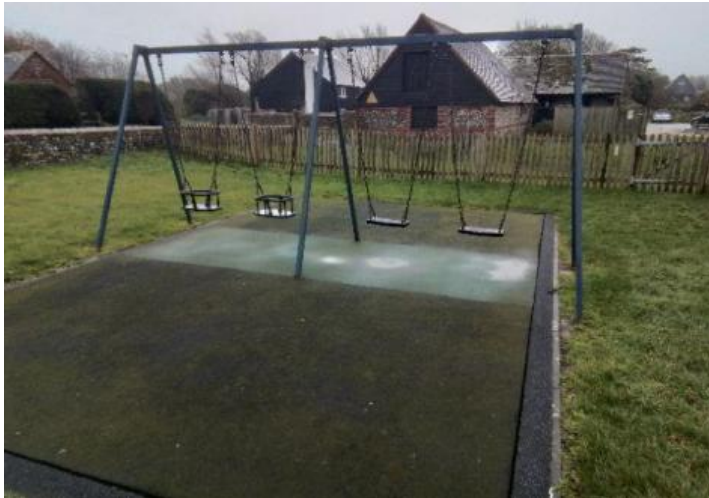
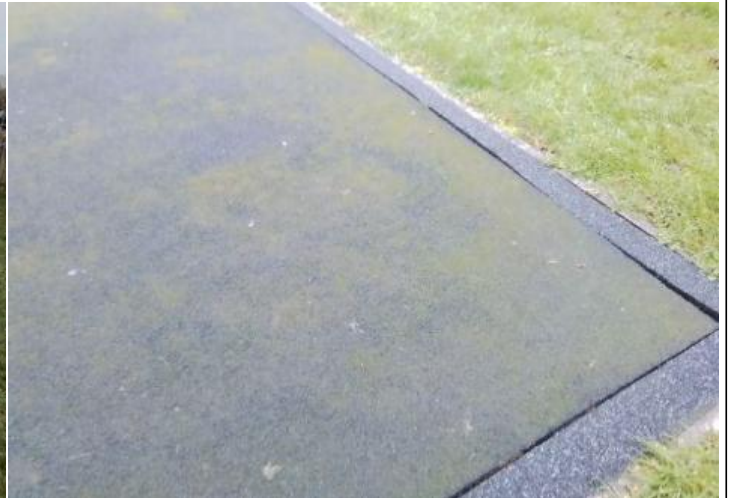
**Finding:** There is algae, silt or moss growth on the surface resulting in slippery conditions  
**Action:** Clean and treat appropriately

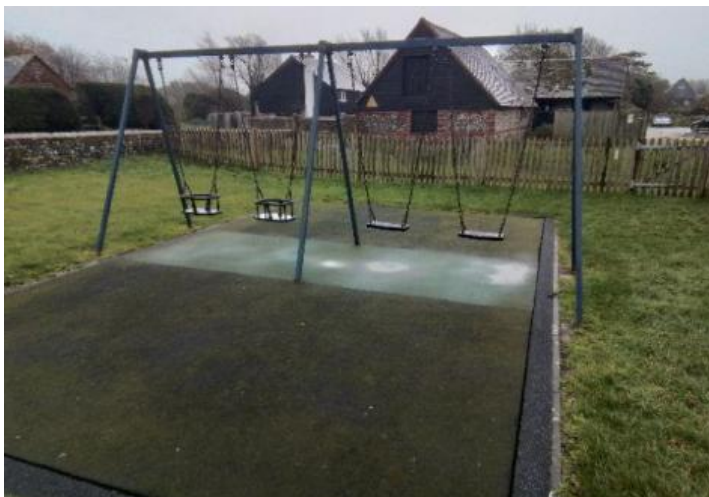
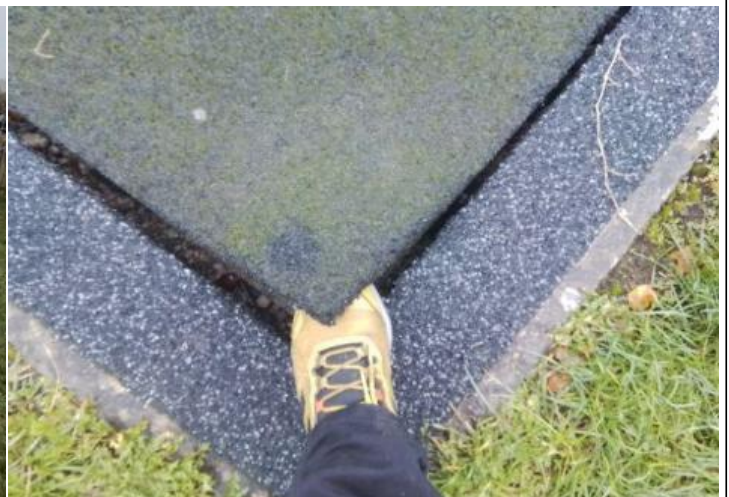
**Finding:** The surface is lifting at the edges and creating trip points  
**Action:** Repair perimeter of surfacing to remove trip points

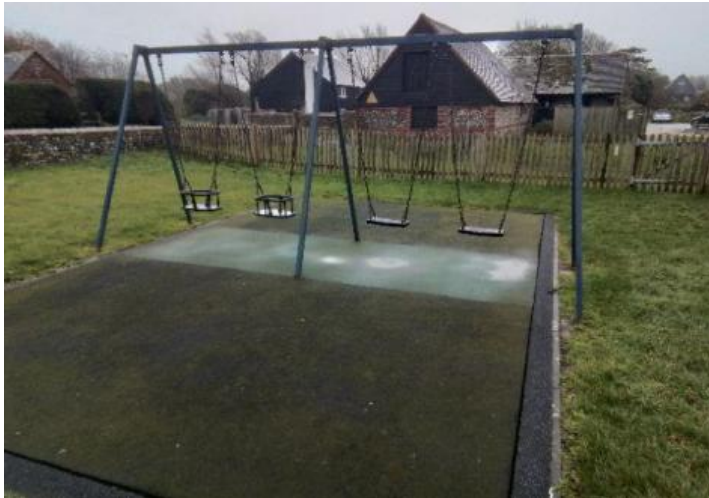
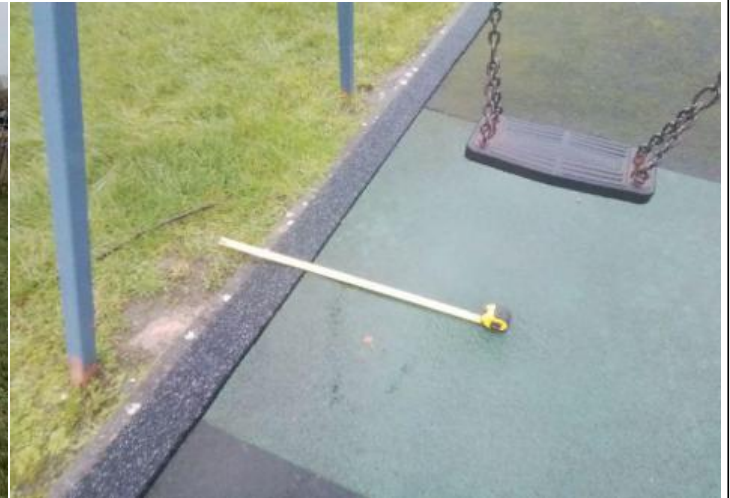
**Finding:** The surfacing width under the seat/s is / are less than 875mm when measured from the centre of the seat outwards, and fails the requirements of BS EN 1176 Part 2

**Action:** Monitor - No remedial work recommended

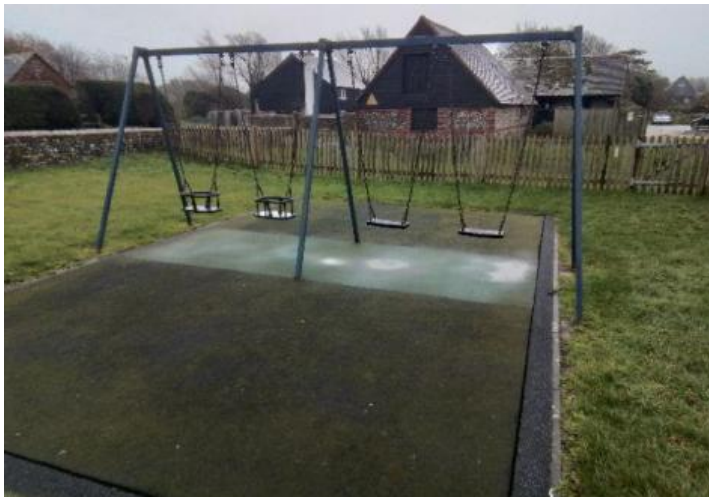
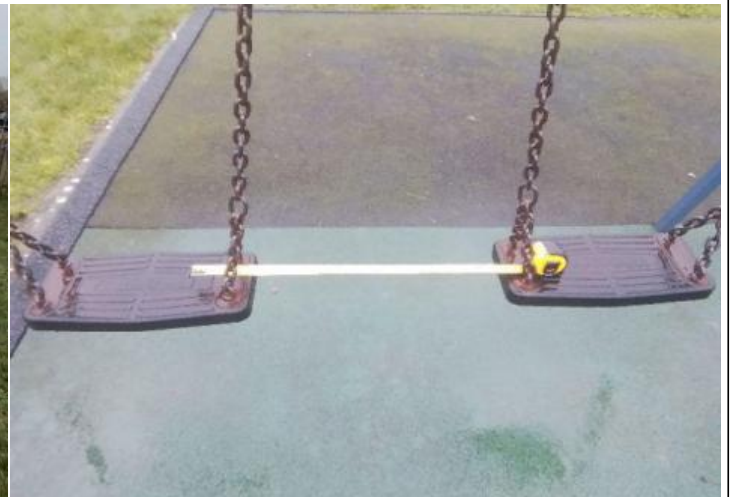
**Finding:** The seats are too close to each other as defined in BS EN 1176 Part 2; this is a low risk failure and no remedial action is required

**Action:** Monitor - No remedial work recommended

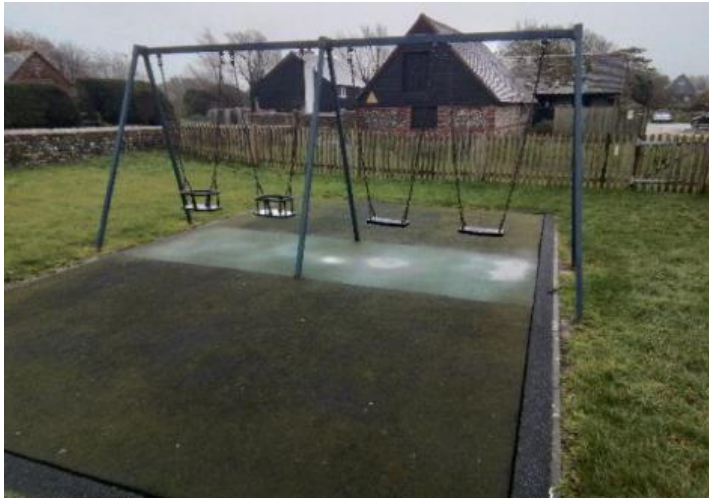
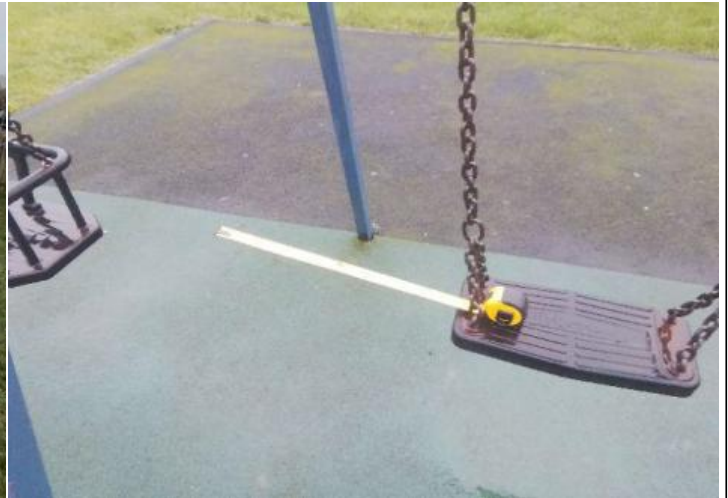
**Finding:** The seats are too close to the frame as defined in BS EN 1176 Part 2; this is a low risk failure and no remedial action is required

**Action:** Monitor - No remedial work recommended

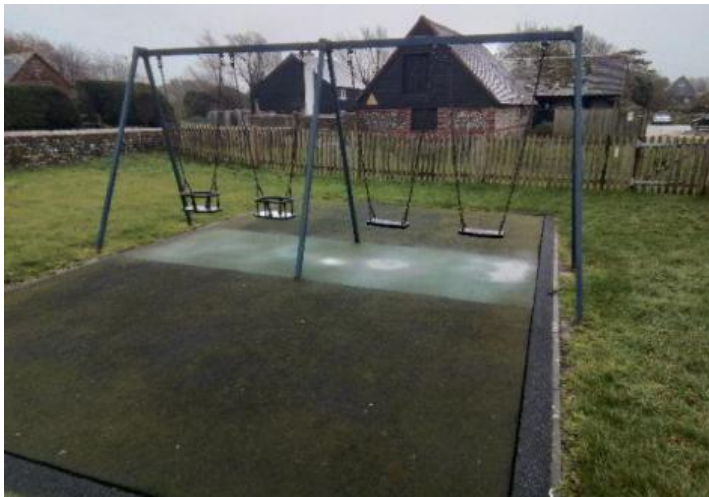
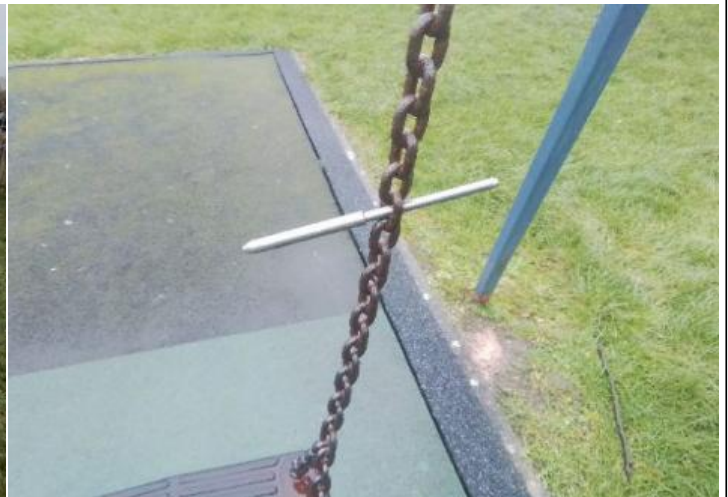
**Finding:** The chain openings are in excess of the 8.6mm as recommended by BS EN 1176

**Action:** Monitor - No remedial work recommended
