## Annual Inspection

Lewes District Council

Glynde Play Area

The Street, Glynde, BN8 6SS

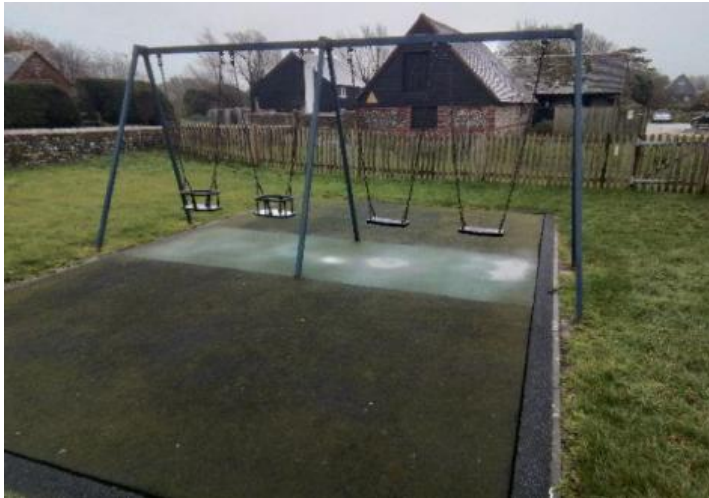
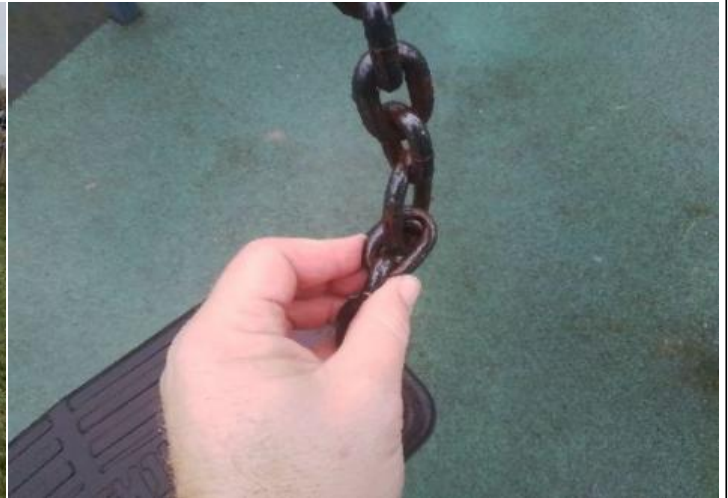
**Finding:** There is some notable evidence of chain wear

**Action:** Monitor for any further deterioration and replace when 40% worn

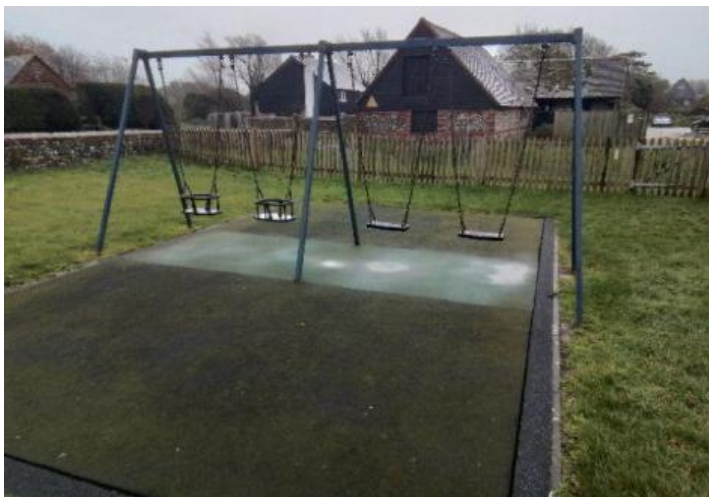
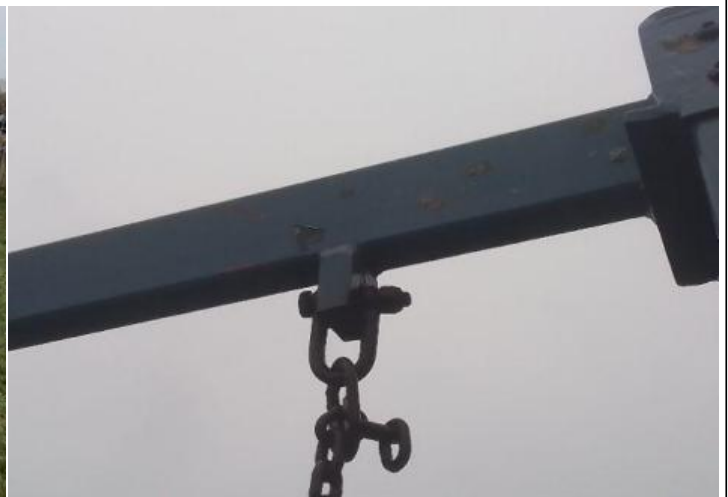
**Finding:** The bushes are worn or missing

**Action:** Replace worn or missing bushes

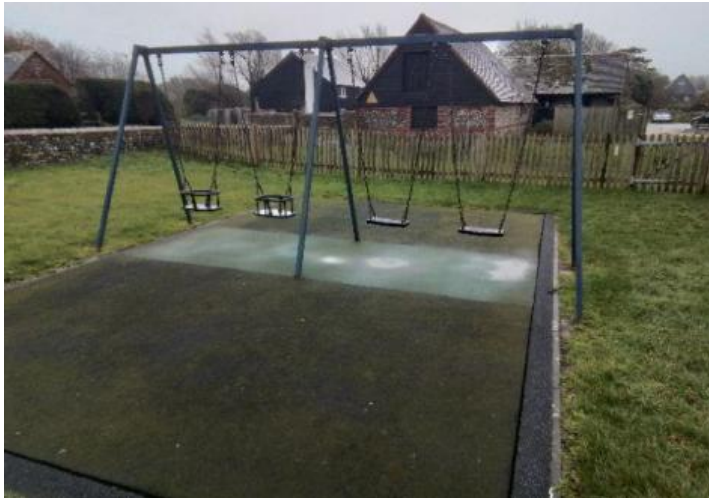
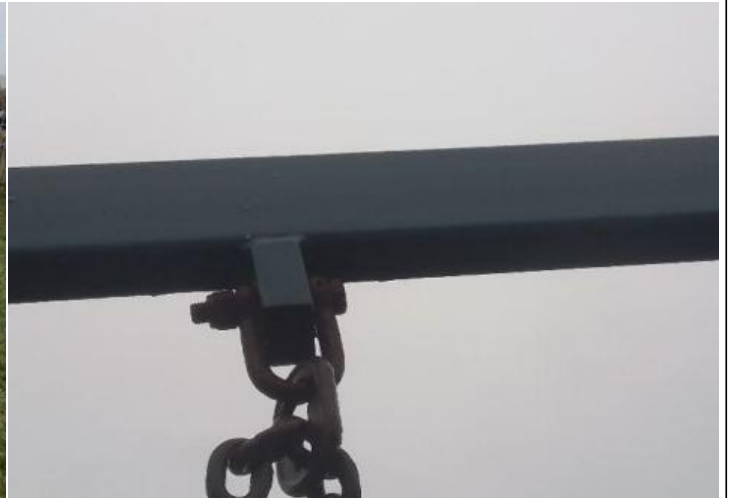
**Finding:** There is some wear to the shackles.

**Action:** Monitor for any further deterioration and replace when 40% worn

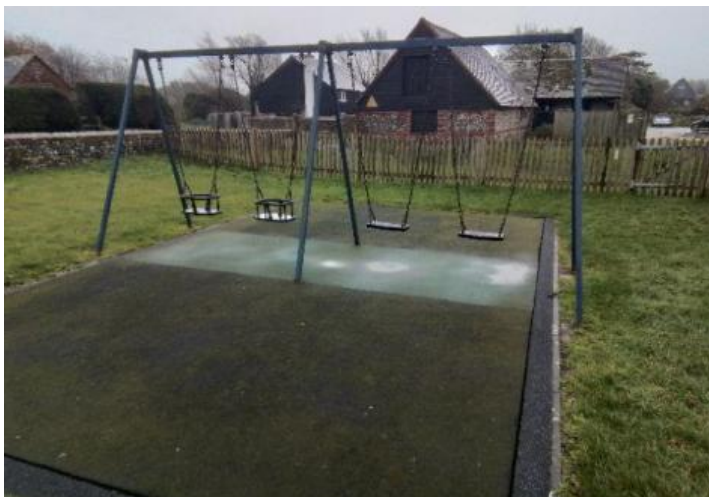
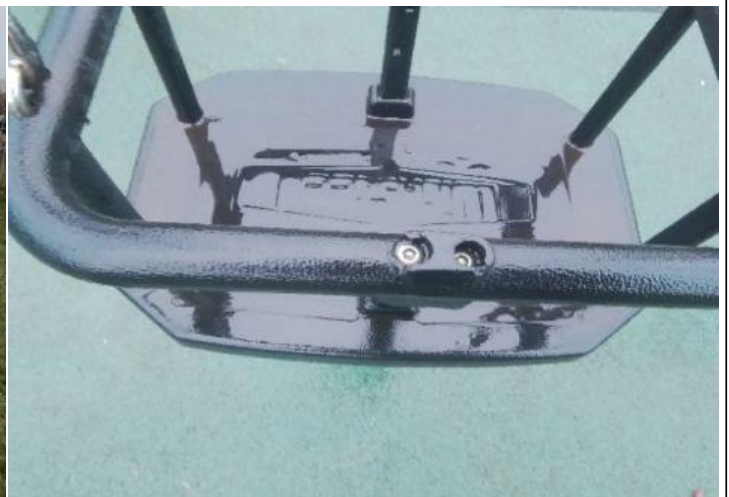
**Finding:** The seat has minor damage or wear

**Action:** Monitor for any further deterioration and replace as required

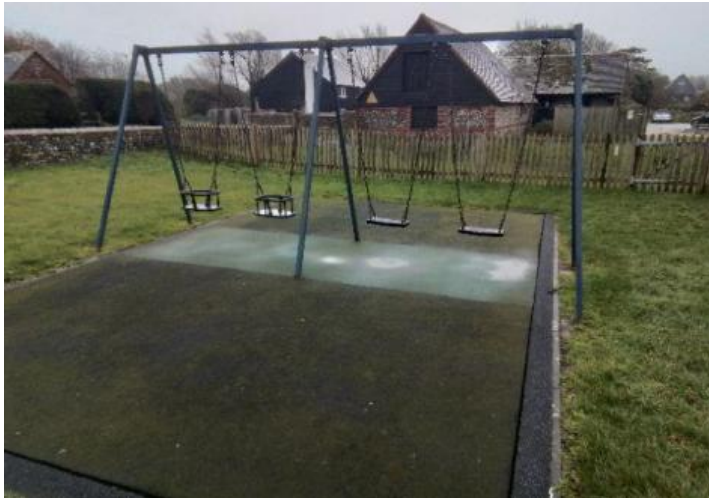
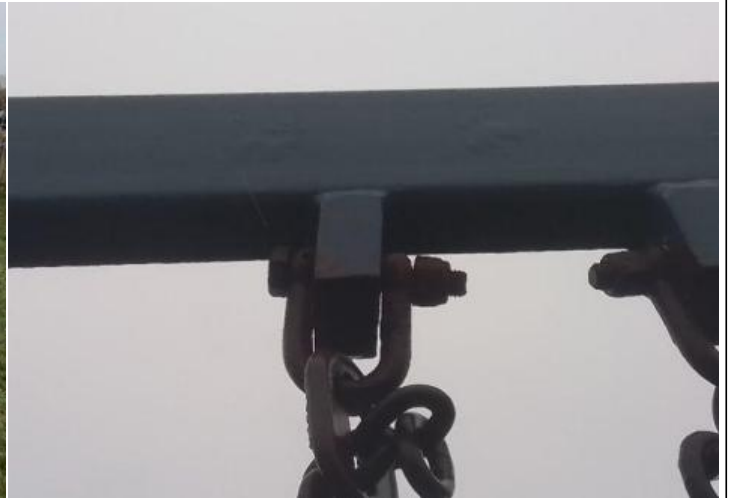
**Finding:** The shackles have corroded excessively

**Action:** Replace

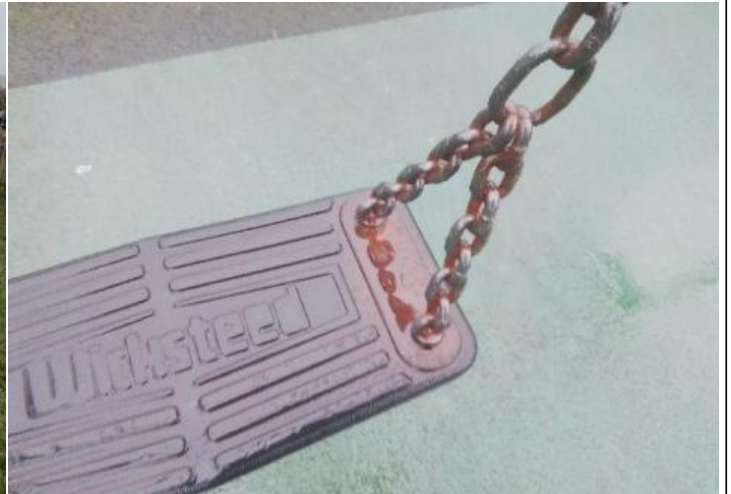
**Finding:** The swing seat connectors are loose

**Action:** Tighten to secure
