Safety Inspection Report

Annual Inspection

Glynde PC - Glynde Rec Play Area

30 October 2024

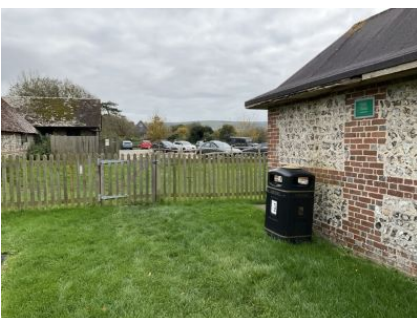
Additional comments are noted below.

Recommend relocating sign to main entrance gate.

Refer to the manufacturer for comment.

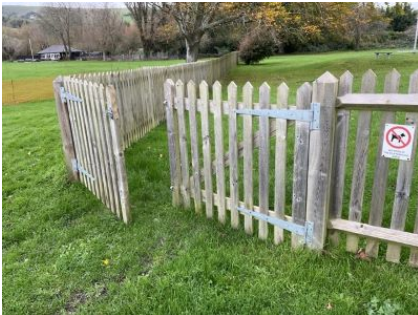
The item is unlocked.

Lock maintenance gate.

Lock.

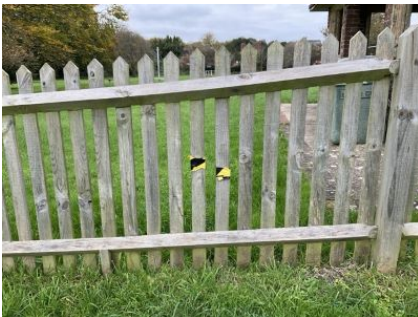
Minor repairs are needed.

Repair/replace any broken slats to fencing.

Replace., Repair.

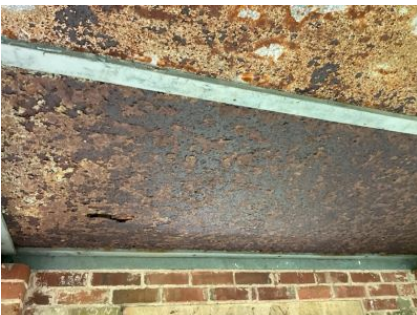
There is significant corrosion on this item.

Shelter roof.

De-scale back to good metal and coat with lead free paint, using appropriate precautions. Repairs may be necessary where corrosion is severe.

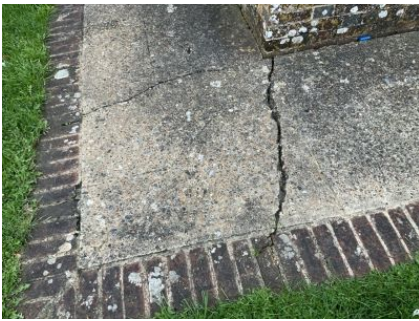
The surface is cracking.

Repair.

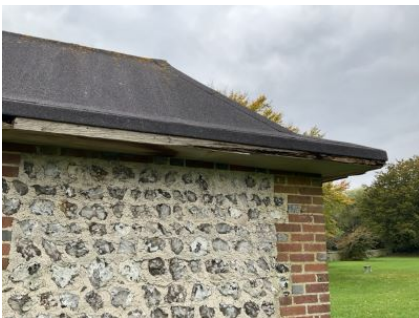
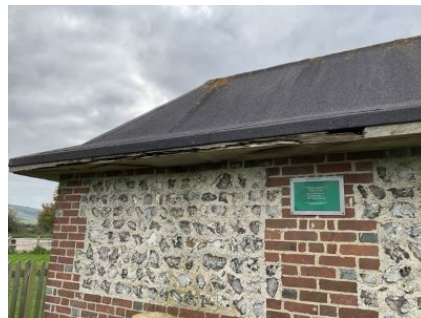
Timber is rotting.

Fascia is rotting. Replace.

Replace.

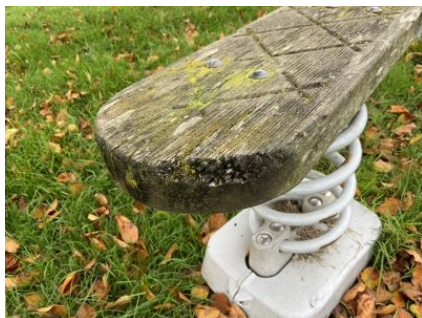
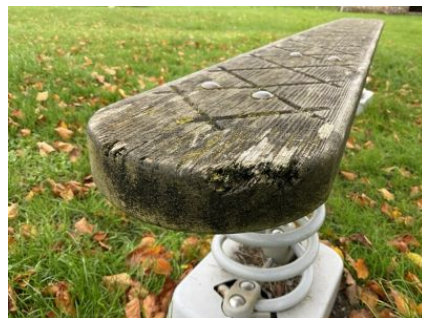
Timber is rotting.

Monitor. Smooth off any rough edges.

No reasonably practicable action is identified.

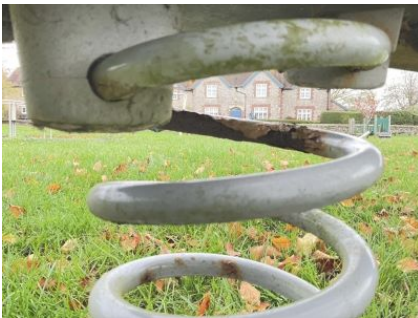
The spring is rusty. These have been known to fail without warning, leading to a collapse of the unit.

Monitor.

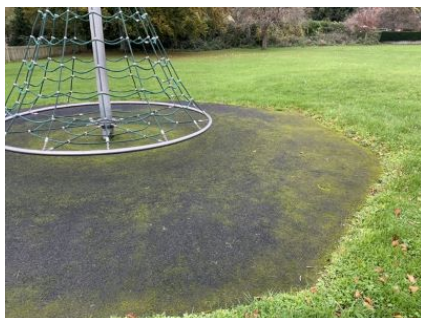
Algae growth giving slippery conditions.

Powerwashing is recommended. Care should be taken to ensure that the material can sustain high pressure washing.

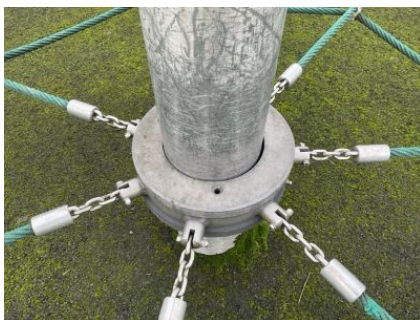
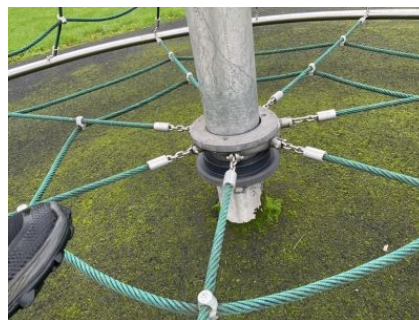
Bolt(s) missing.

Central bolts missing from top cover. Replace.

Replace missing bolt(s).

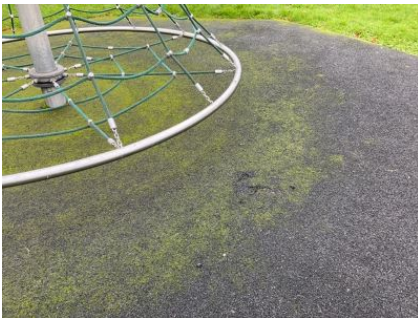
Surface is wearing.

Repair.

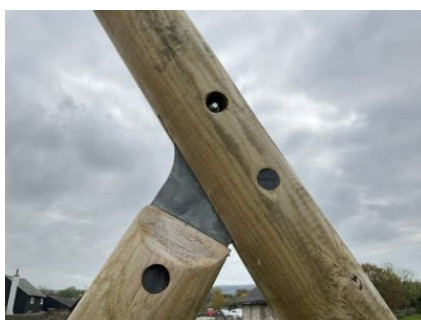
Cap missing.

Replace.

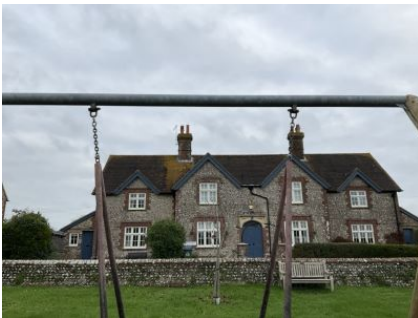
A secondary support device is required to prevent collapse in the event of supporting component failure.

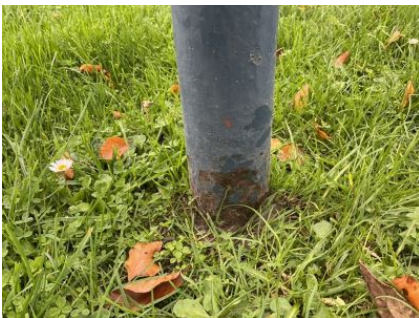
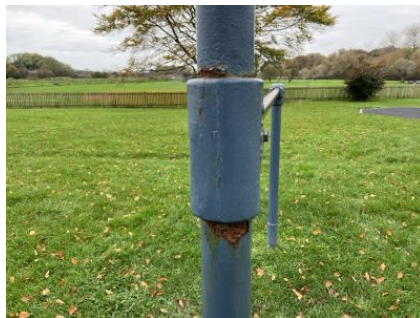
Paintwork is in poor condition.

De-scale back to good base material and coat with lead free paint, using appropriate precautions. Repairs may be necessary where corrosion is severe.

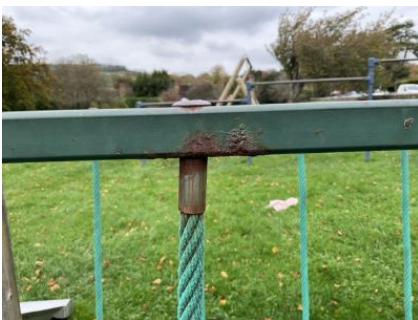
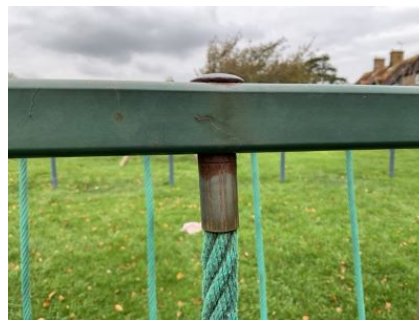
Item is rusting in places.

Repair rust damage, dismantle rope to inspect for internal rust. Replace if necessary.

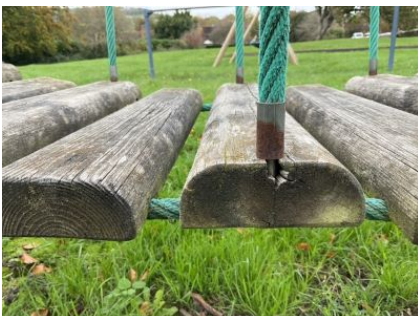
Some planks are rotting at joints. Replace.

Replace rotten timbers.

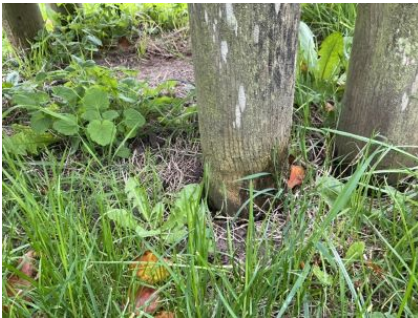
Strimmer damage is present on posts, allowing water to enter and timbers to soften. It can also remove the protective envelope around the timber. Prevent further damage and check timbers for decay throughout the year.

Prevent further damage.

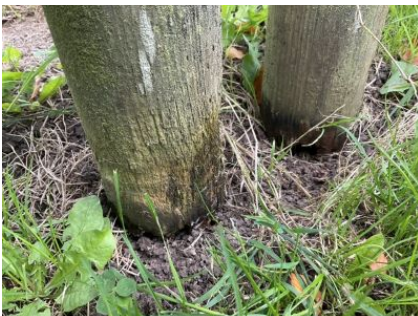
Timber is decayed.

Supports are decayed and need to be replaced.

Replace affected parts.

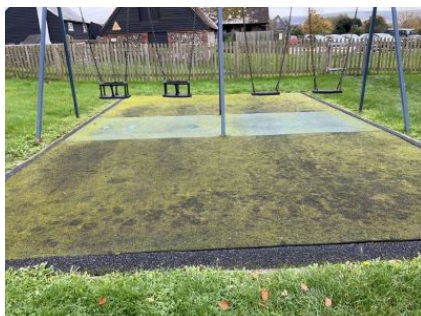
Algae growth giving slippery conditions.

Powerwashing is recommended. Care should be taken to ensure that the material can sustain high pressure washing.

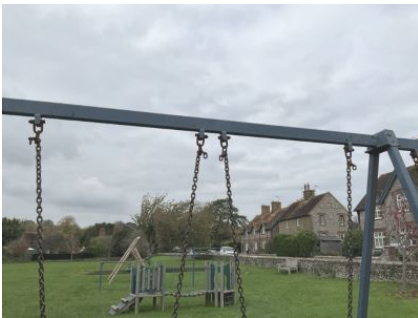
There is wear in the bushes.

Remove shackle bolt and check bush and shackle pin wear, replacing as necessary.

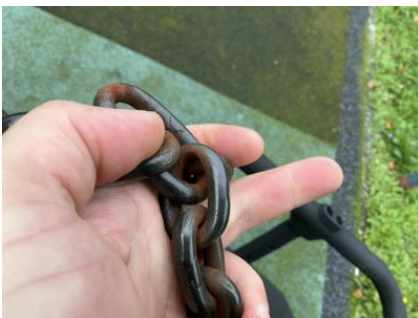
Some chain wear.

Monitor for further deterioration and replace before 40% wear.

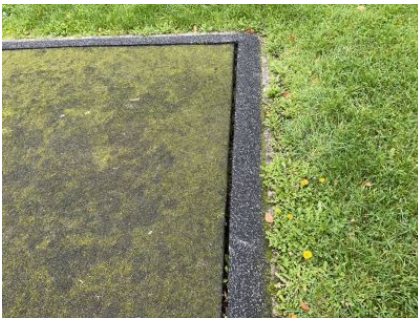
Shrinkage / separation of the surface. This may give a trip hazard.

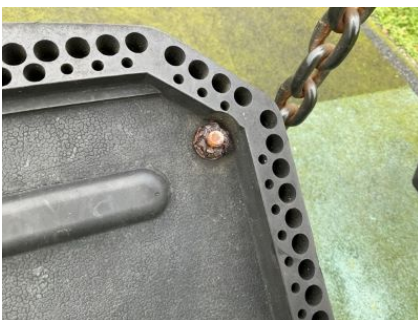
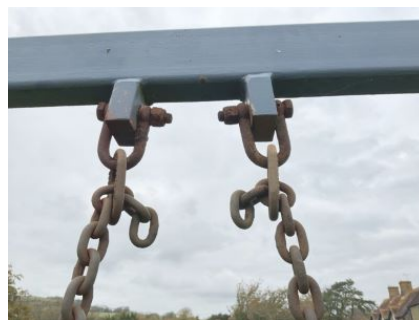
Fittings are rusty.

Rusty nuts and shackles.

Replace.

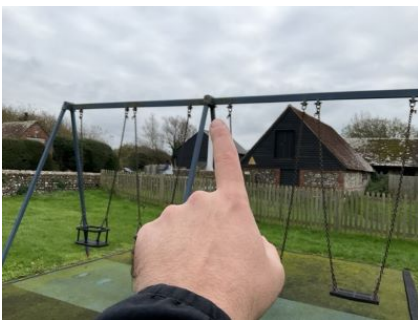
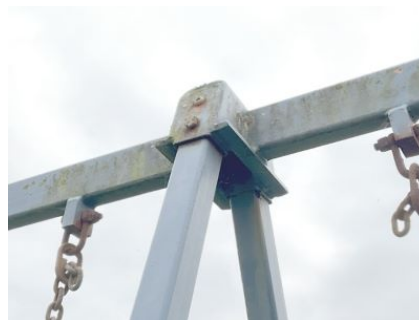
Supports loose in head blocks.

Tighten retaining nuts in the head block wedge. If this fails, fit shims (metal wedges) between supports and block to secure.
