## Annual Inspection

Lewes District Council

Glynde Play Area

The Street, Glynde, BN8 6SS

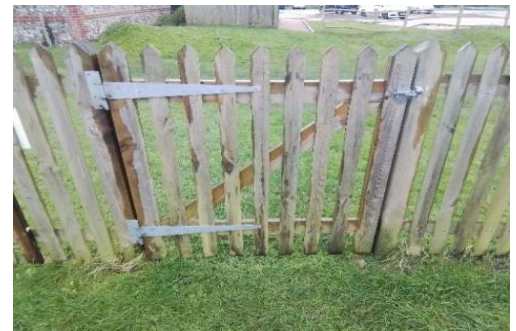
**Item:** Gate - Self Closing  
**Manufacturer:** Not Identified  
**Surface Type:** Grass  
**Item Quantity:** 2  
**Equipment Compliance:** N/A  
**Surface Area Compliance:** N/A

There are openings that are less than 12mm that could trap or crush fingers - Provide a 12mm gap throughout full range of motion at both sides of gate

A number of fixing(s) have worked loose - Secure all loose fixings

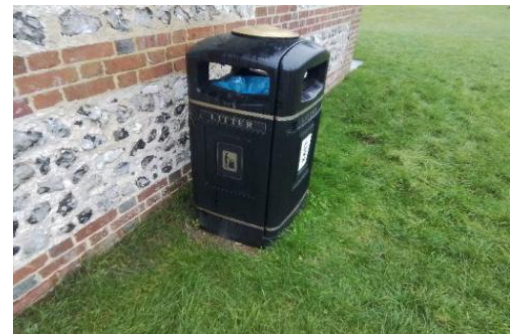
**Item:** Litter Bin  
**Manufacturer:** Broxap  
**Surface Type:** Grass  
**Item Quantity:** 2  
**Equipment Compliance:** N/A  
**Surface Area Compliance:** N/A

There is some damage to the bin - Monitor for any further deterioration and replace as required

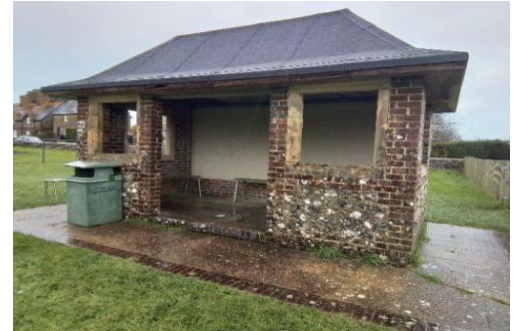
**Item:** Shelter  
**Manufacturer:** Not Identified  
**Surface Type:** Concrete  
**Item Quantity:** 1  
**Equipment Compliance:** N/A  
**Surface Area Compliance:** N/A  
**Life Expectancy:** 5 -10 Years  
**Total Findings:** 3

The concrete pad is damaged - Repair affected areas

There are areas or parts of the roof timbers that have rotted  
 - Replace all affected timbers

There is surface corrosion / rust present on the item -  
 Consider treating the item

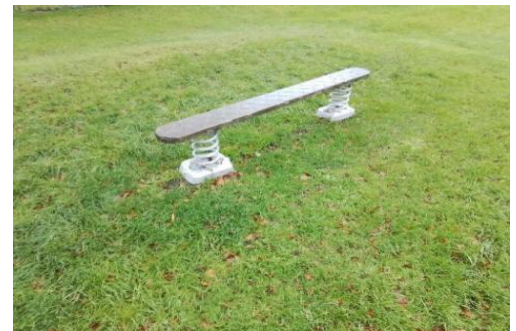
**Item:** Spring Balance Beam  
**Manufacturer:** Playdale Playgrounds Ltd  
**Surface Type:** Grass  
**Item Quantity:** 1  
**Equipment Compliance:** Yes  
**Surface Area Compliance:** Yes  
**Life Expectancy:** 3 - 5 Years  
**Total Findings:** 3

Parts of the timber are rough or splintered - Remove all  
 rough or sharp edges

The paintwork on the spring has been damaged or worn  
 exposing the metal underneath which is rusting - Treat any  
 rusting components and repaint

There is some evidence of rot in the timber - Monitor for any  
 further deterioration and replace as required

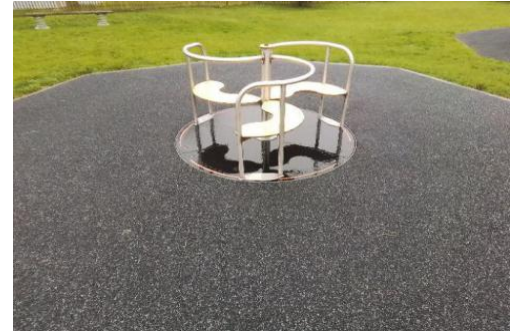
**Item:** Inclusive Roundabout  
**Manufacturer:** Playdale Playgrounds Ltd  
**Surface Type:** Wet Pour  
**Item Quantity:** 1  
**Equipment Compliance:** Yes  
**Surface Area Compliance:** Yes  
**Life Expectancy:** 5 -10 Years  
**Total Findings:** 2

There are trip hazards at the edges of the surface - Reinstate surrounding surface levels to remove the trip points

The bearing is worn / damaged and the item is not operating correctly - Repair / replace

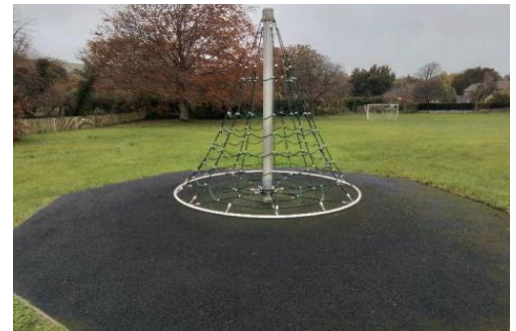
**Item:** Cone Climber  
**Manufacturer:** Tayplay Ltd  
**Surface Type:** Wet Pour  
**Item Quantity:** 1  
**Equipment Compliance:** No  
**Surface Area Compliance:** Yes  
**Life Expectancy:** 5 -10 Years  
**Total Findings:** 6

The height to the underside of the rim is less than 400mm and fails the requirements of BS EN 1176 Part 5 - Monitor - No remedial work recommended

There is or are fixings missing on the item - Replace all missing fixings

There are areas or parts of the timber edging surrounding the play equipment that have rotted - Replace all affected timbers

There are trip hazards at the edges of the surface - Reinstate surrounding surface levels to remove the trip points

There is some minor damage to the surface - Monitor for any further deterioration and repair as required

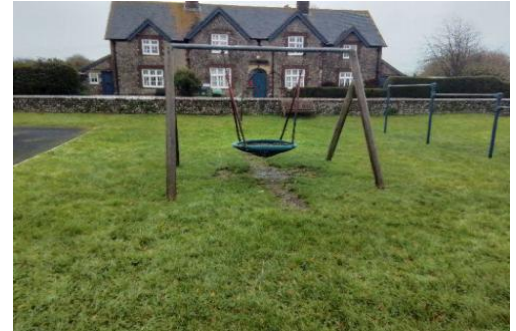
**Item:** Basket Swing - Type 1  
**Manufacturer:** Playdale Playgrounds Ltd  
**Surface Type:** Grass Matrix Tiles  
**Item Quantity:** 1  
**Equipment Compliance:** No  
**Surface Area Compliance:** Yes  
**Life Expectancy:** 3 - 5 Years  
**Total Findings:** 11

Swings of this design should have a secondary safety mechanism fitted to prevent collapse of the seat in the event of a joint failure to comply with BS EN 1176 Part 2, however this swing was installed prior to the standards being updated in 2018 and the manufacturer has confirmed that the joint was independently cycle tested by BSi - Monitor use and check the joint and fixing security regularly

There is some strimmer / machinery damage apparent on the posts, this can penetrate the preservative applied to the timber and accelerate the rotting process - Monitor for any deterioration (rot) and replace as required

There are areas or parts of the posts x4 on the structure that have rotted - Replace all affected timbers

The seat bushes are showing signs of wear - Monitor for any further deterioration and replace as required

The bushes are showing signs of wear - Monitor for any further deterioration and replace as required

There is some notable evidence of chain wear - Monitor for any further deterioration and replace when 40% worn

There is some wear to the connecting links - Monitor for any further deterioration and replace when 40% worn

The chain openings are in excess of the 8.6mm as recommended by BS EN 1176 - Monitor - No remedial work recommended

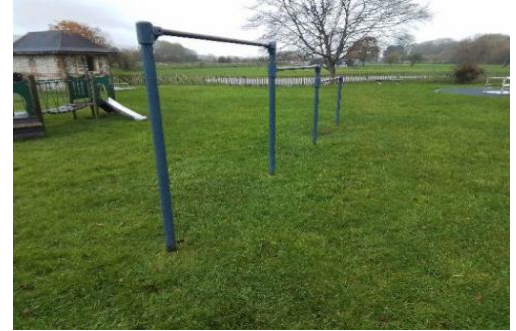
**Item:** Somersault Bars  
**Manufacturer:** Not Identified  
**Surface Type:** Grass  
**Item Quantity:** 1  
**Equipment Compliance:** No  
**Surface Area Compliance:** Yes  
**Life Expectancy:** 5 -10 Years  
**Total Findings:** 3

There are post / end caps missing from the item - Replace missing post caps

The paintwork on this item has been damaged or worn exposing the metal underneath which is rusting / corroding - Treat affected areas and repaint

There is/are finger entrapment/s in the framework and the item fails to meet the requirements of BS EN 1176 Part 1 4.2.7.6 Entrapment of fingers - Monitor - No remedial work recommended

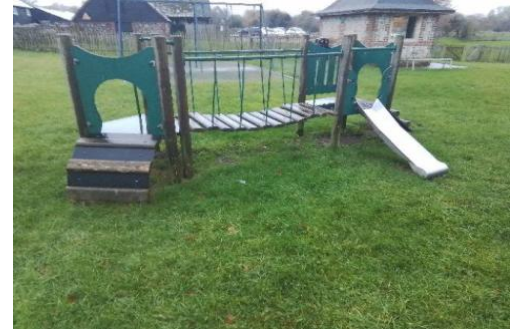
**Item:** Multi Play (Toddler)  
**Manufacturer:** Playdale Playgrounds Ltd  
**Surface Type:** Grass Matrix Tiles  
**Item Quantity:** 1  
**Equipment Compliance:** Yes  
**Surface Area Compliance:** Yes  
**Life Expectancy:** 3 - 5 Years  
**Total Findings:** 5

There is some strimmer / machinery damage apparent on the posts, this can penetrate the preservative applied to the timber and accelerate the rotting process - Monitor for any deterioration (rot) and replace as required

There is some evidence of rot in the timber - Monitor for any further deterioration and replace as required

A number of rope fixing(s) have worked loose - Secure all loose fixings

There are areas or parts of the posts x6 on the structure that have rotted with evidence of rot in the remaining posts - Replace all affected timbers

The paintwork on this item has been damaged or worn exposing the metal underneath which is rusting / corroding - Treat affected areas and repaint

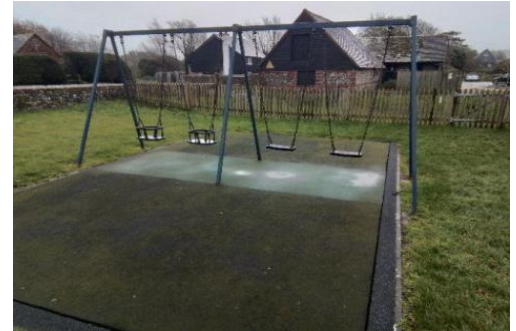
**Item:** 2 Bay (2 Flat, 2 Cradle)  
**Manufacturer:** Wicksteed Playgrounds  
**Surface Type:** Wet Pour  
**Item Quantity:** 1  
**Equipment Compliance:** No  
**Surface Area Compliance:** No  
**Life Expectancy:** 5 -10 Years  
**Total Findings:** 13

There are gaps opening between the surfacing and the edging surround or between the joints in the surfacing - Monitor for any further deterioration and repair as required

The surface is lifting at the edges and creating trip points - Repair perimeter of surfacing to remove trip points

The seats are too close to each other as defined in BS EN 1176 Part 2; this is a low risk failure and no remedial action is required - Monitor - No remedial work recommended

The chain openings are in excess of the 8.6mm as recommended by BS EN 1176 - Monitor - No remedial work recommended

The bushes are worn or missing - Replace worn or missing bushes

The seat has minor damage or wear - Monitor for any further deterioration and replace as required

The swing seat connectors are loose - Tighten to secure

There is algae, silt or moss growth on the surface resulting in slippery conditions - Clean and treat appropriately

The surfacing width under the seat/s is / are less than 875mm when measured from the centre of the seat outwards, and fails the requirements of BS EN 1176 Part 2 - Monitor - No remedial work recommended

The seats are too close to the frame as defined in BS EN 1176 Part 2; this is a low risk failure and no remedial action is required - Monitor - No remedial work recommended

There is some notable evidence of chain wear - Monitor for any further deterioration and replace when 40% worn

There is some wear to the shackles. - Monitor for any further deterioration and replace when 40% worn

The shackles have corroded excessively - Replace

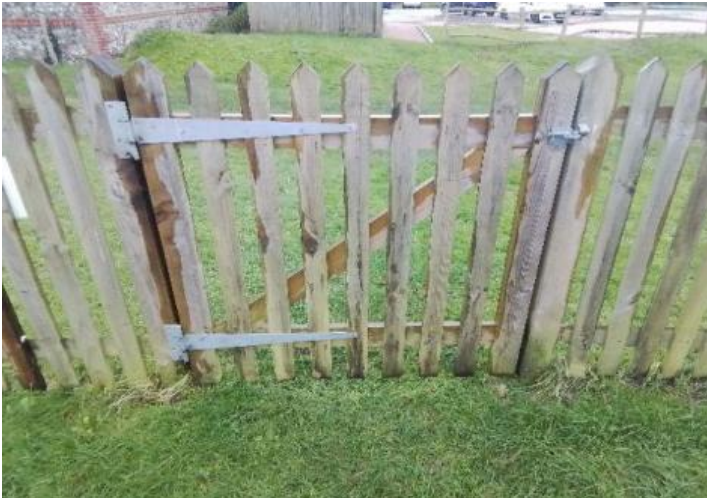
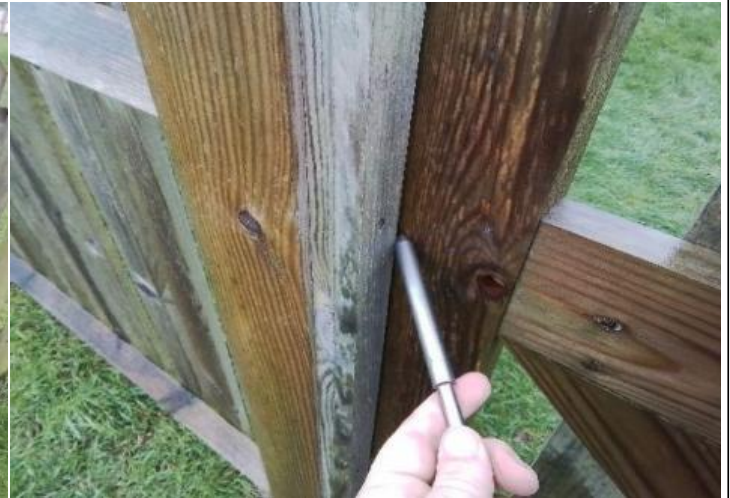
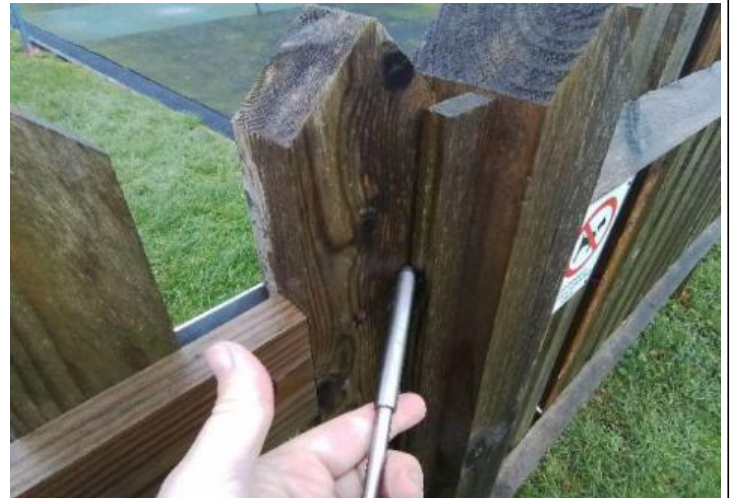
**Item:** Gates - Gate - Self Closing  
**Manufacturer:** Not Identified

**Finding:** There are openings that are less than 12mm that could trap or crush fingers

**Action:** Provide a 12mm gap throughout full range of motion at both sides of gate

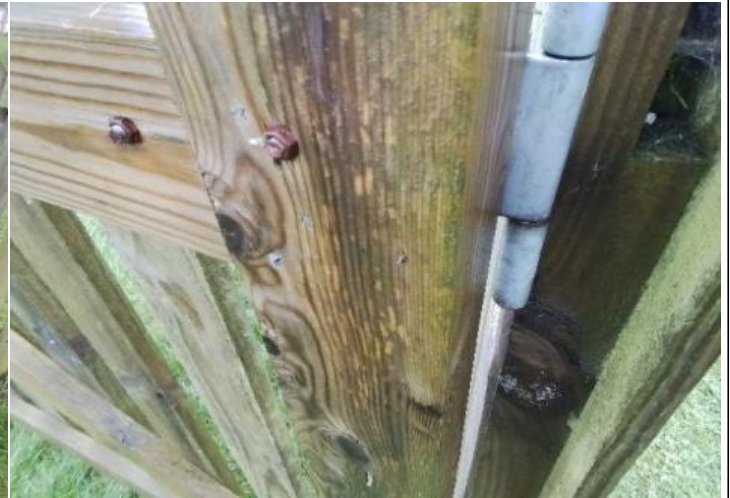
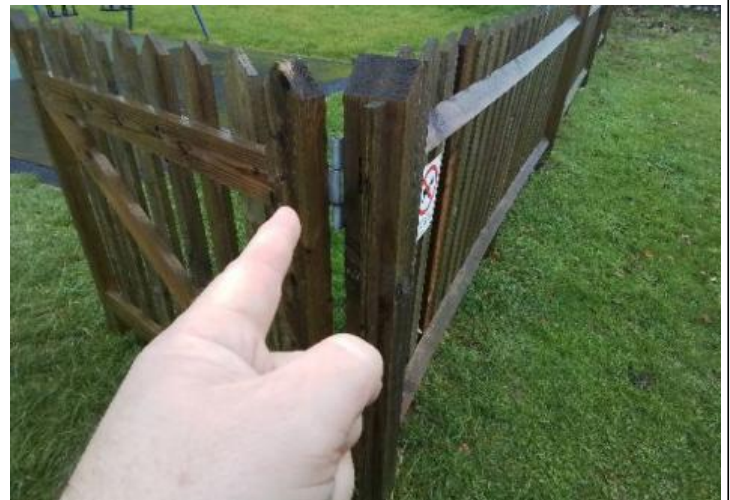
**Item:** Gates - Gate - Self Closing  
**Manufacturer:** Not Identified

**Finding:** There are projecting nail ends present

**Action:** Remove and provide more appropriate fixings if required

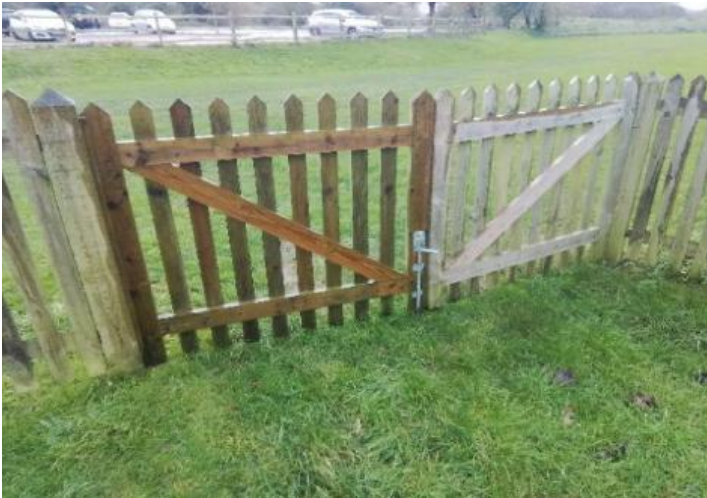
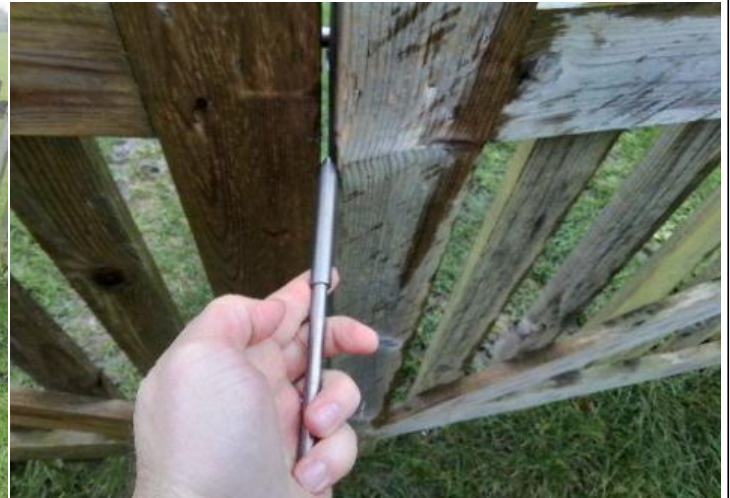
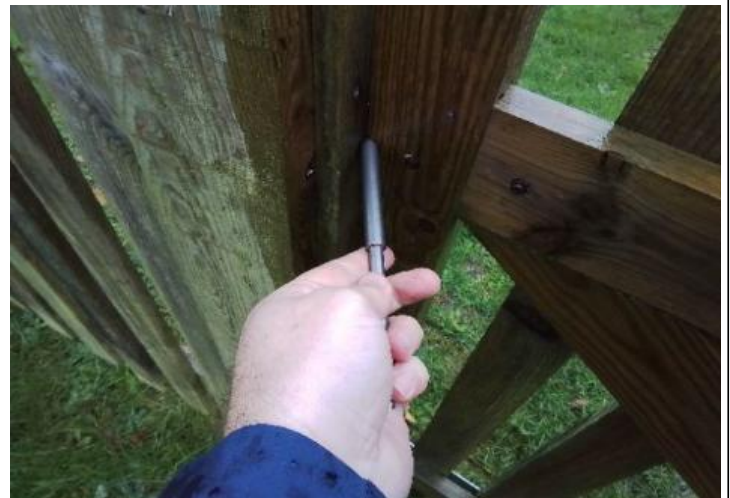
**Item:** Gates - Gate - Maintenance  
**Manufacturer:** Not Identified

**Finding:** There are openings that are less than 12mm that could trap or crush fingers

**Action:** Provide a 12mm gap throughout full range of motion at both sides of gate

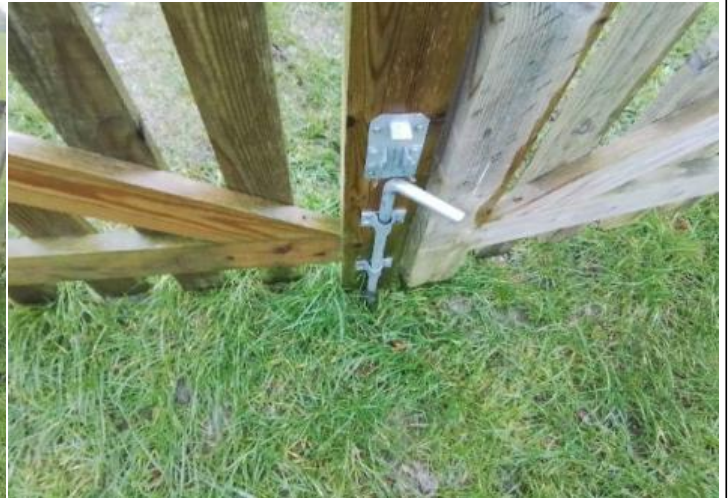
**Item:** Gates - Gate - Maintenance  
**Manufacturer:** Not Identified

**Finding:** There is no padlock on the maintenance gate

**Action:** Provide a padlock to secure the gate

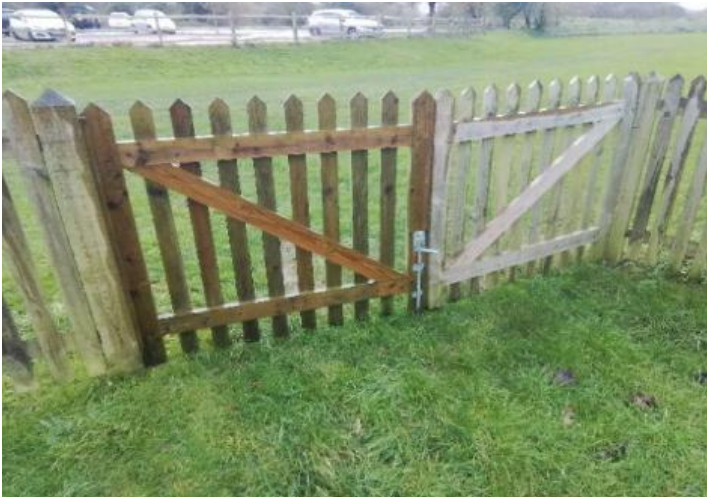
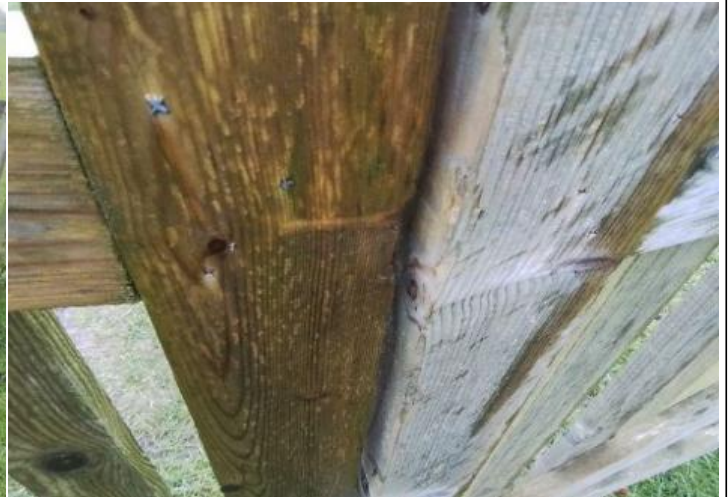
**Item:** Gates - Gate - Maintenance  
**Manufacturer:** Not Identified

**Finding:** Parts of the timber are rough or splintered

**Action:** Remove all rough or sharp edges

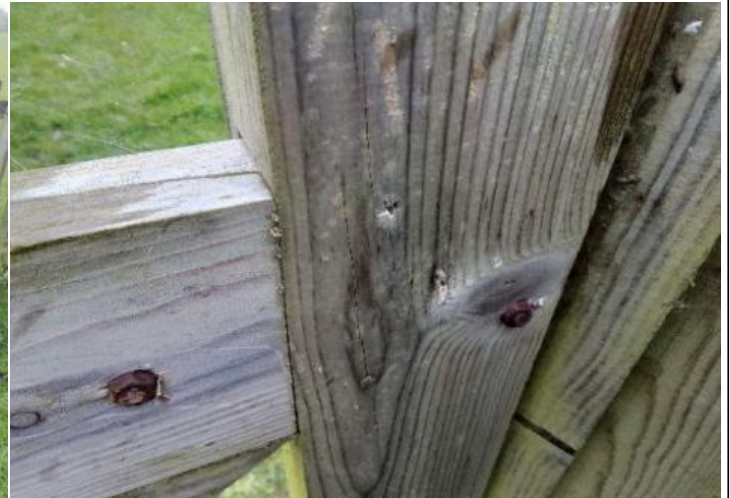
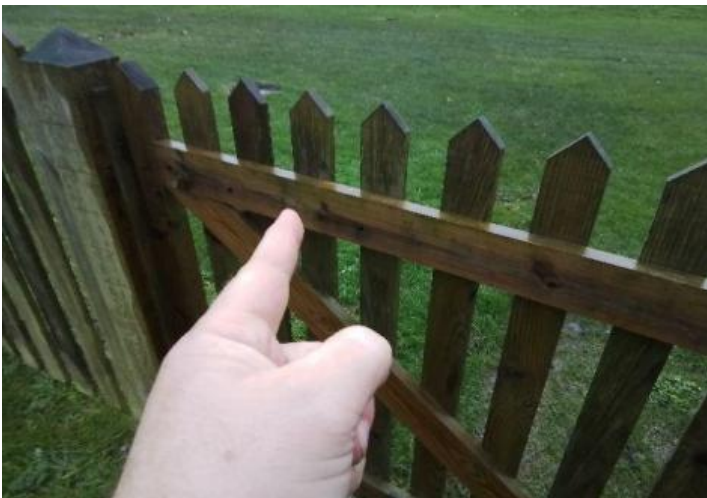
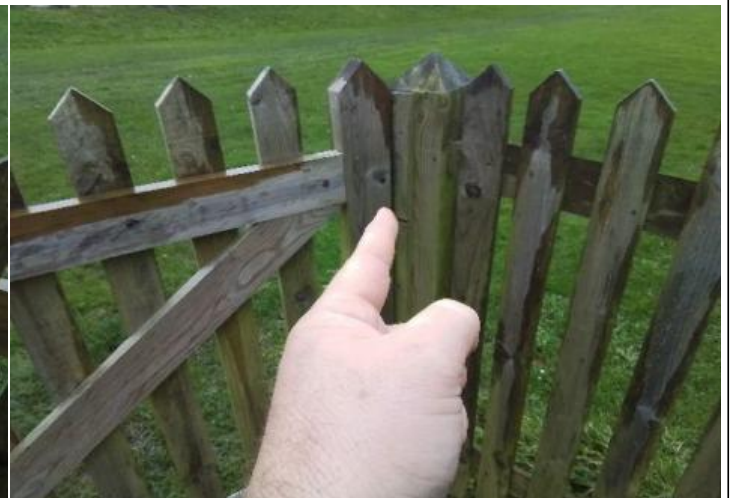
**Item:** Gates - Gate - Maintenance  
**Manufacturer:** Not Identified

**Finding:** There are projecting nail ends present

**Action:** Remove and provide more appropriate fixings if required

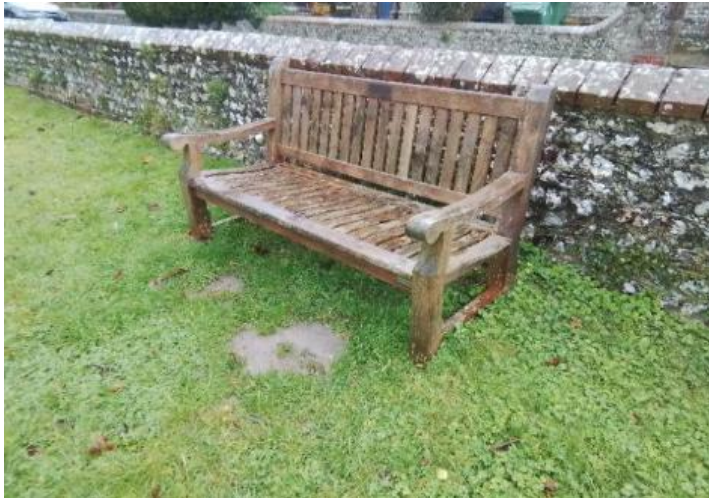
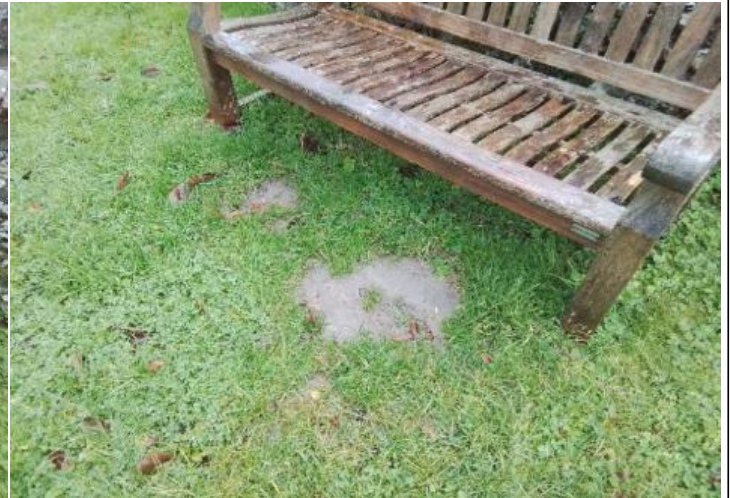
**Item:** Ancillary Items - Bench  
**Manufacturer:** Not Identified

**Finding:** The area around the item has eroded and may become slippery

**Action:** Reinststate eroded area

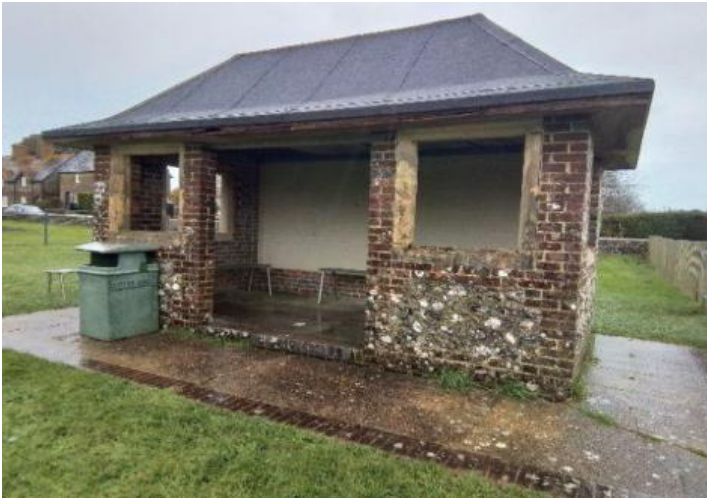
**Item:** Ancillary Items - Shelter  
**Manufacturer:** Not Identified

**Finding:** The concrete pad is damaged

**Action:** Repair affected areas

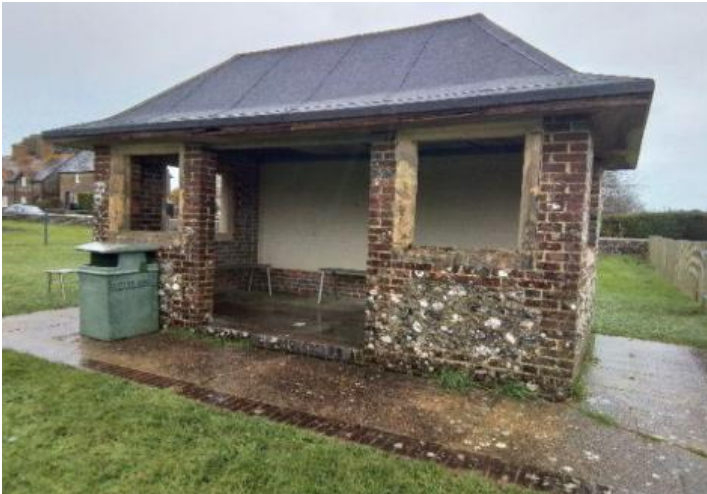
**Item:** Ancillary Items - Shelter  
**Manufacturer:** Not Identified

**Finding:** There are areas or parts of the roof timbers that have rotted

**Action:** Replace all affected timbers

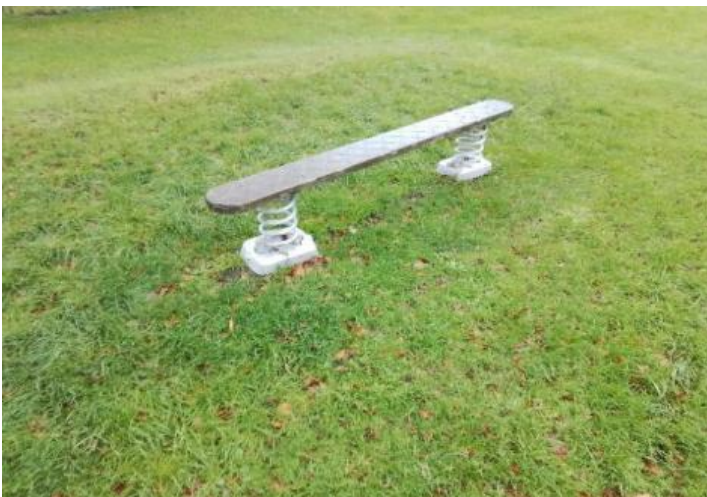
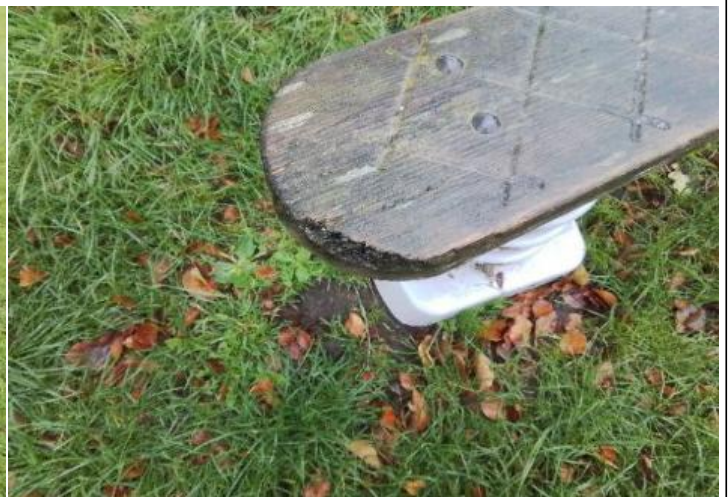
**Item:** Activity Equipment - Spring Balance Beam  
**Manufacturer:** Playdale Playgrounds Ltd

**Finding:** Parts of the timber are rough or splintered

**Action:** Remove all rough or sharp edges

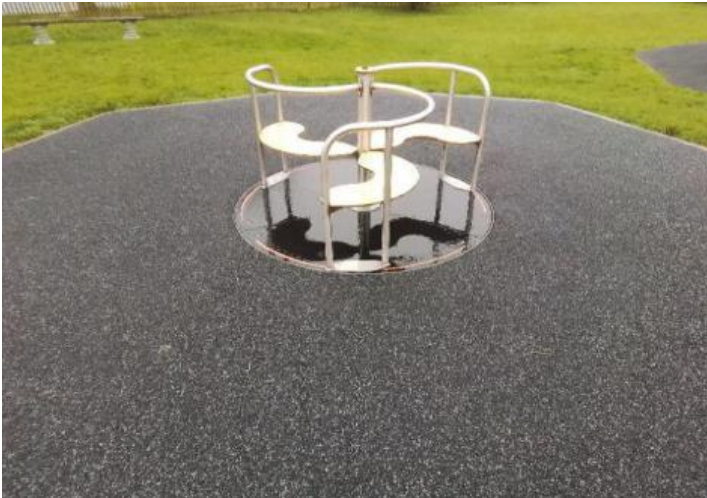
**Item:** Rotor Play - Inclusive Roundabout  
**Manufacturer:** Playdale Playgrounds Ltd

**Finding:** There are trip hazards at the edges of the surface

**Action:** Reinstate surrounding surface levels to remove the trip points

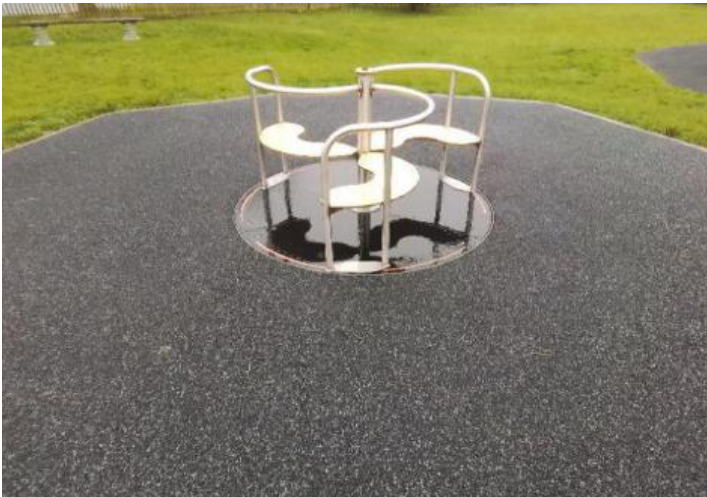
**Item:** Rotor Play - Inclusive Roundabout  
**Manufacturer:** Playdale Playgrounds Ltd

**Finding:** The bearing is worn / damaged and the item is not operating correctly

**Action:** Repair / replace

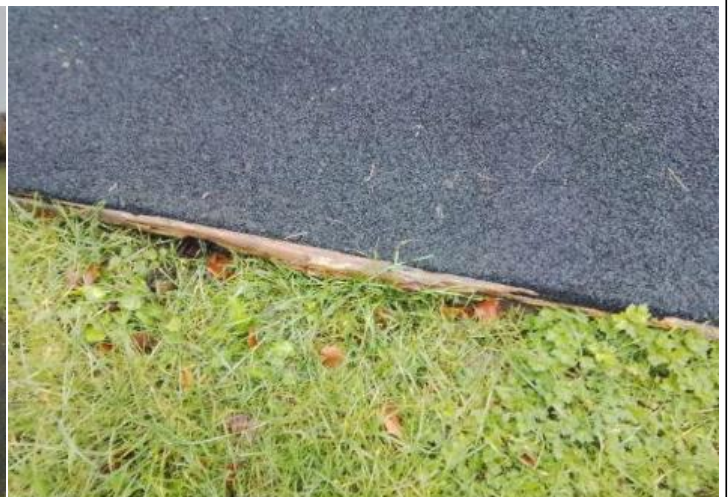
**Item:** Rotor Play - Cone Climber  
**Manufacturer:** Tayplay Ltd

**Finding:** Parts of the timber edging are rough or splintered

**Action:** Remove all rough or sharp edges

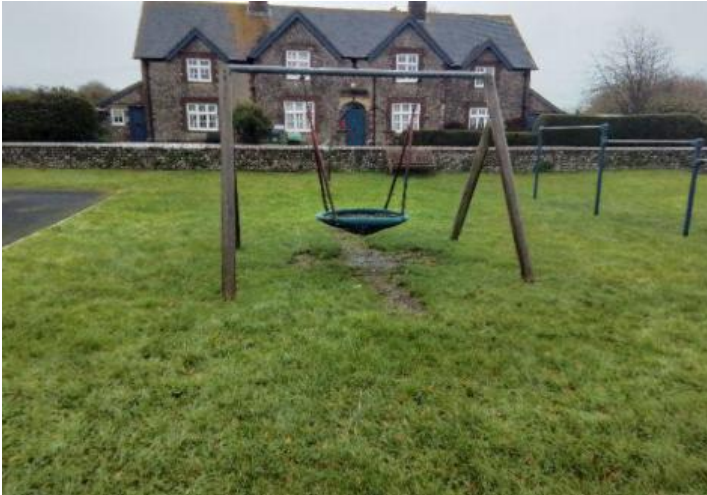
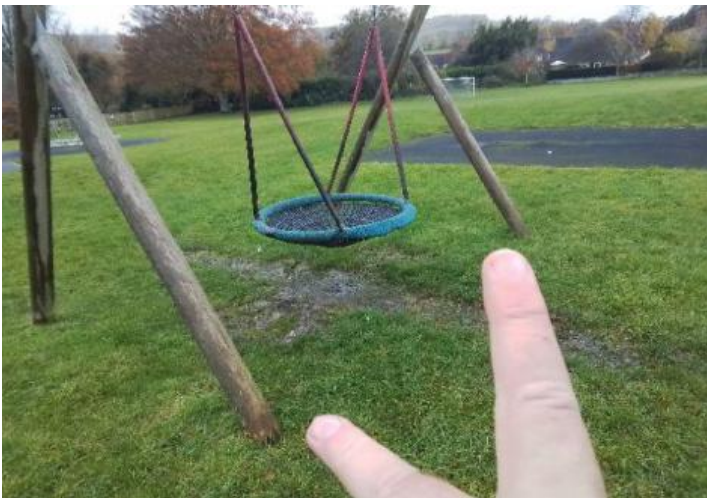
**Item:** Swings - Basket Swing - Type 1  
**Manufacturer:** Playdale Playgrounds Ltd

**Finding:** There are areas or parts of the posts x4 on the structure that have rotted

**Action:** Replace all affected timbers

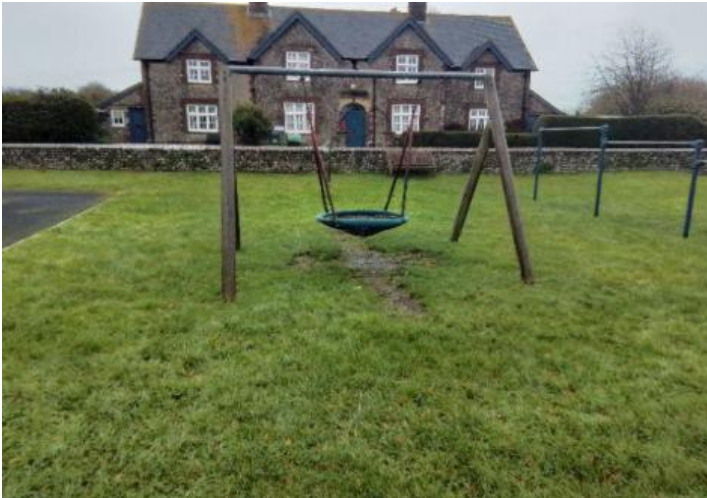
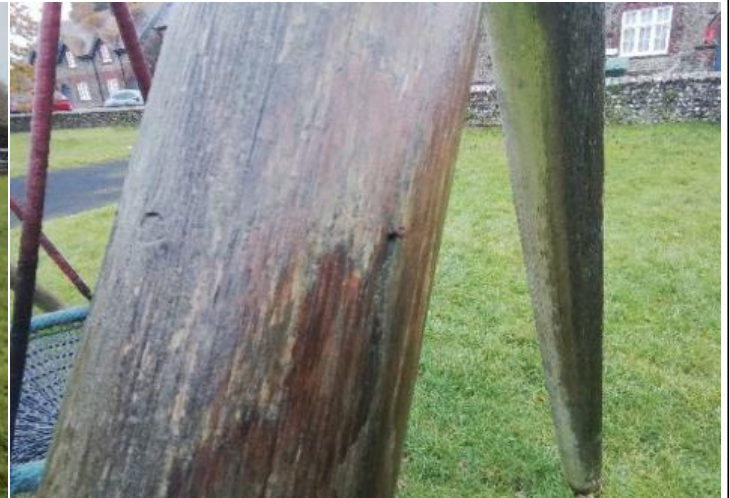
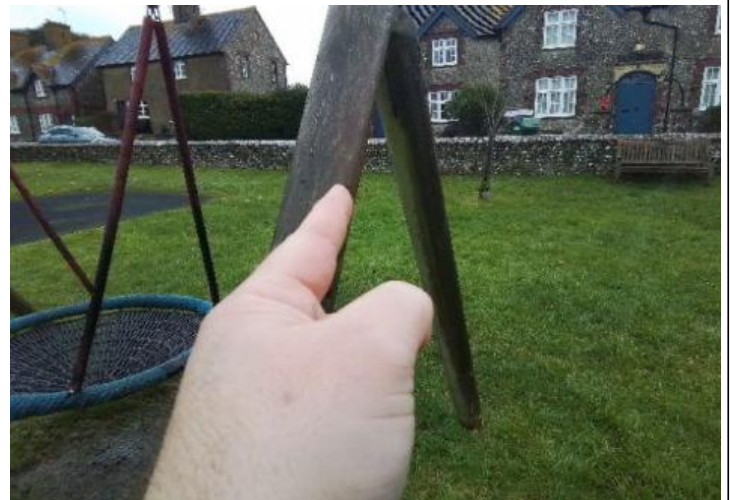
**Item:** Swings - Basket Swing - Type 1  
**Manufacturer:** Playdale Playgrounds Ltd

**Finding:** There are projecting nail ends present

**Action:** Remove and provide more appropriate fixings if required

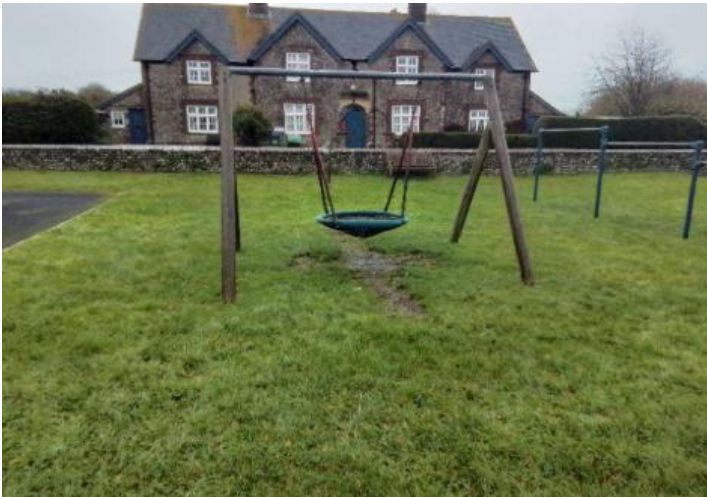
**Item:** Swings - Basket Swing - Type 1  
**Manufacturer:** Playdale Playgrounds Ltd

**Finding:** The bushes are showing signs of wear

**Action:** Monitor for any further deterioration and replace as required

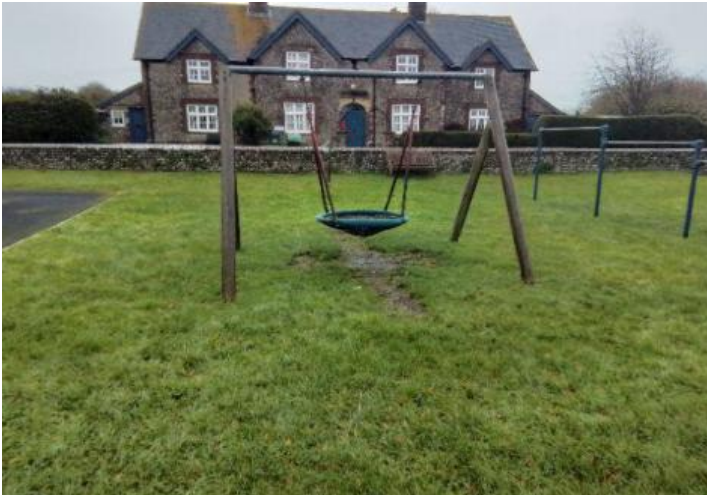
**Item:** Swings - Basket Swing - Type 1  
**Manufacturer:** Playdale Playgrounds Ltd

**Finding:** There is some notable evidence of chain wear

**Action:** Monitor for any further deterioration and replace when 40% worn

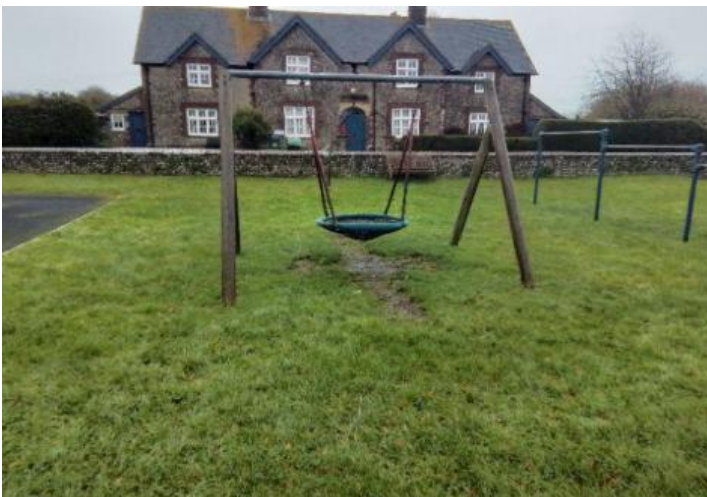
**Item:** Swings - Basket Swing - Type 1  
**Manufacturer:** Playdale Playgrounds Ltd

**Finding:** There is some wear to the connecting links

**Action:** Monitor for any further deterioration and replace when 40% worn

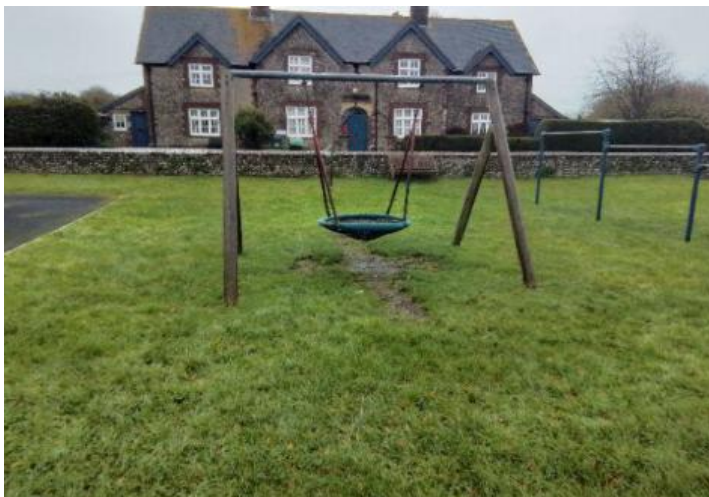
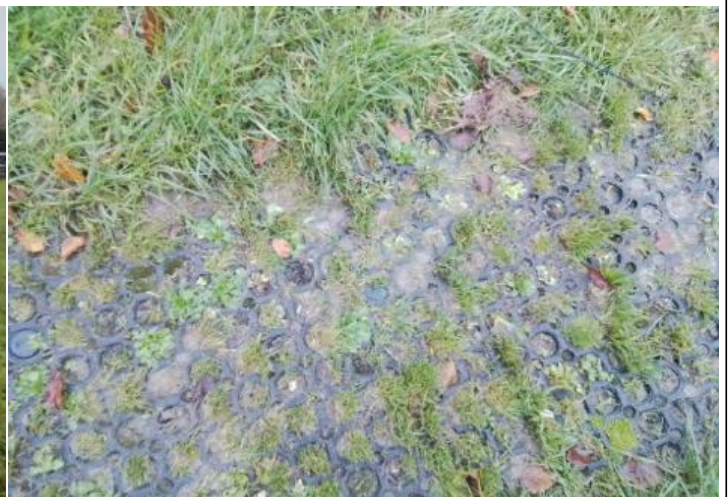
**Item:** Swings - Basket Swing - Type 1  
**Manufacturer:** Playdale Playgrounds Ltd

**Finding:** Fixing Pins have been installed in the impact areas of the grass mats **Action:** Remove pins from impact areas

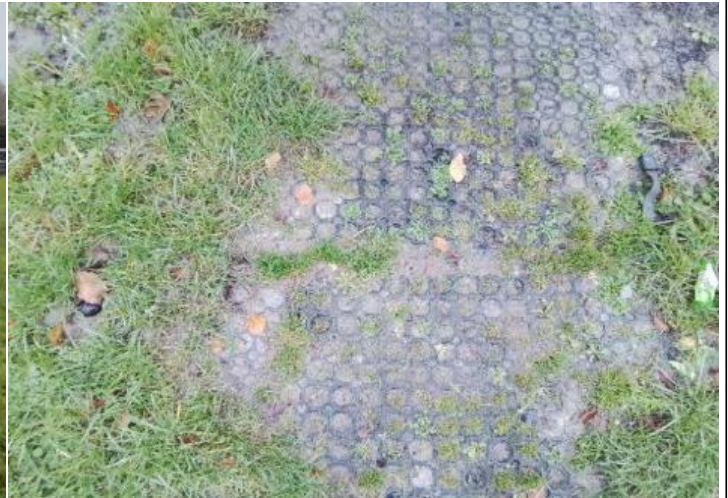
**Item:** Swings - Basket Swing - Type 1  
**Manufacturer:** Playdale Playgrounds Ltd

**Finding:** There are gaps opening between the grass mat tiles

**Action:** Provide additional ties or secure / reinstate surface tiles

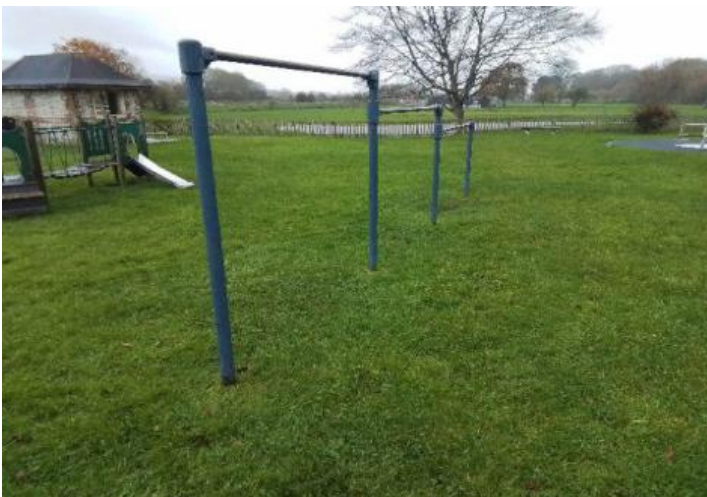
**Item:** Activity Equipment - Somersault Bars  
**Manufacturer:** Not Identified

**Finding:** There are post / end caps missing from the item

**Action:** Replace missing post caps

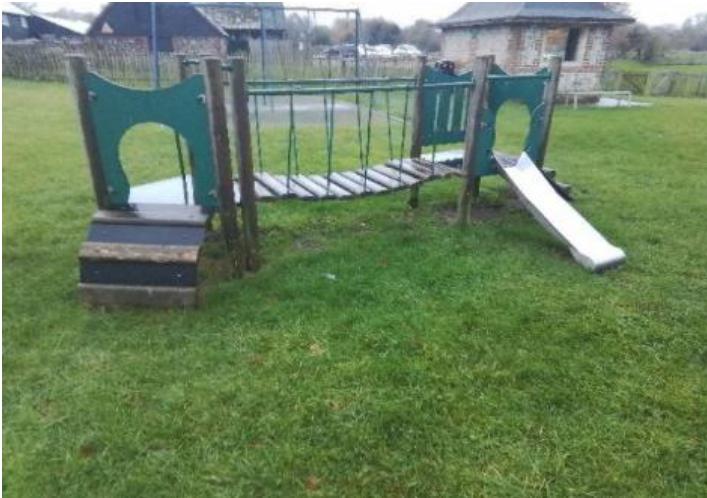
**Item:** Activity Equipment - Multi Play (Toddler)  
**Manufacturer:** Playdale Playgrounds Ltd

**Finding:** There is some strimmer / machinery damage apparent on the posts, this can penetrate the preservative applied to the timber and accelerate the rotting process

**Action:** Monitor for any deterioration (rot) and replace as required

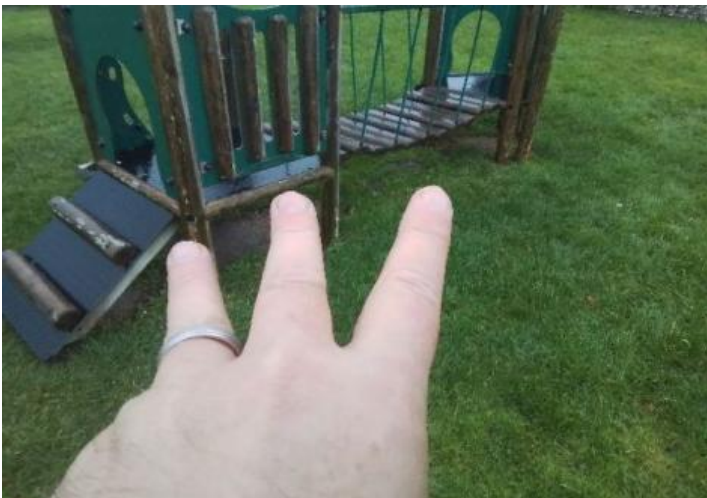
**Item:** Activity Equipment - Multi Play (Toddler)  
**Manufacturer:** Playdale Playgrounds Ltd

**Finding:** There are areas or parts of the posts x6 on the structure that have rotted with evidence of rot in the remaining posts

**Action:** Replace all affected timbers

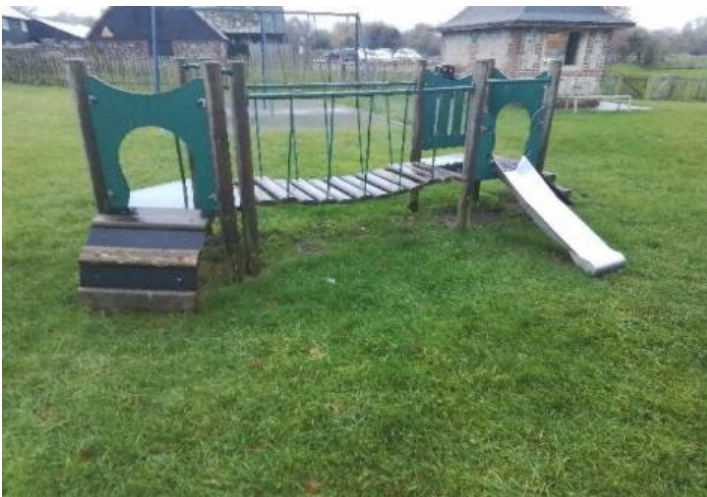
**Item:** Activity Equipment - Multi Play (Toddler)  
**Manufacturer:** Playdale Playgrounds Ltd

**Finding:** The paintwork on this item has been damaged or worn exposing the metal underneath which is rusting / corroding

**Action:** Treat affected areas and repaint

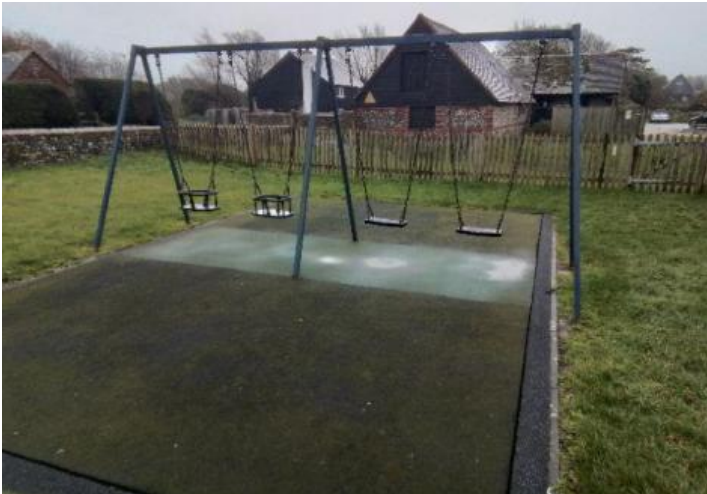
**Item:** Swings - 2 Bay (2 Flat, 2 Cradle)  
**Manufacturer:** Wicksteed Playgrounds

**Finding:** There are gaps opening between the surfacing and the edging surround or between the joints in the surfacing

**Action:** Monitor for any further deterioration and repair as required

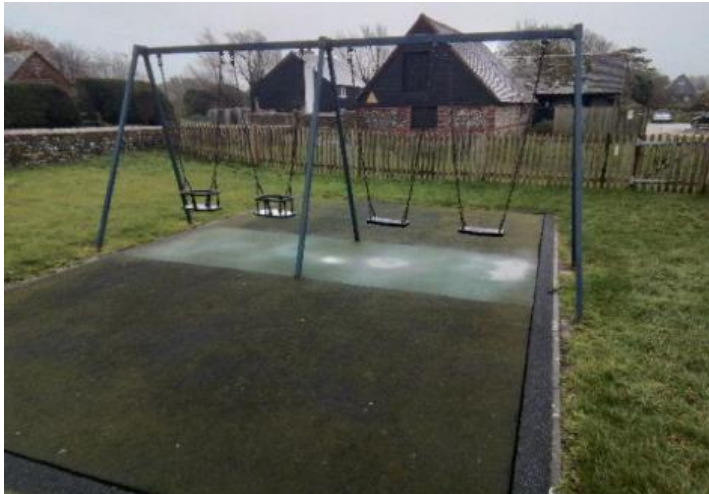
**Item:** Swings - 2 Bay (2 Flat, 2 Cradle)  
**Manufacturer:** Wicksteed Playgrounds

**Finding:** The swing seat connectors are loose

**Action:** Tighten to secure
