Safety Inspection Report

Annual Inspection

Glynde PC - Glynde Rec Play Area

30 October 2024

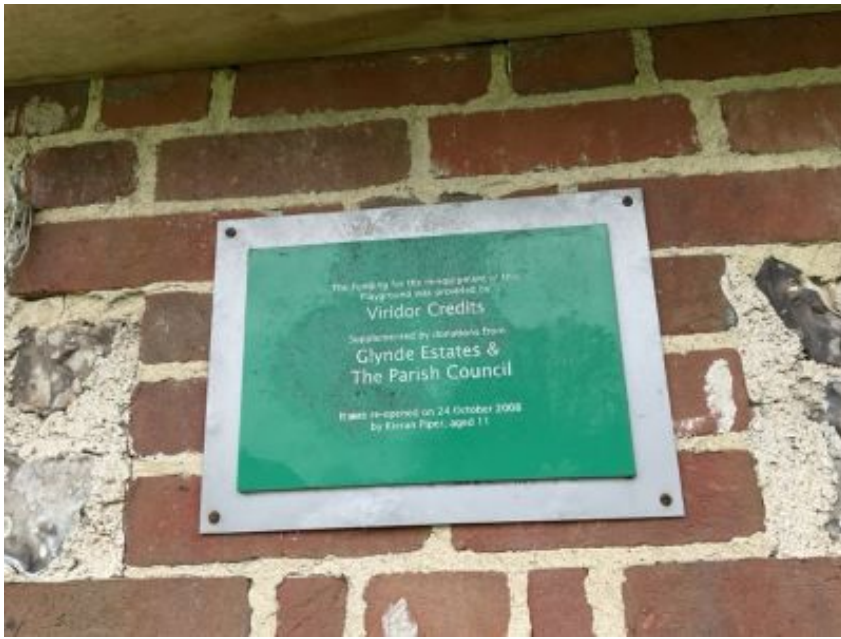
Signage

Additional comments are noted below.

Recommend relocating sign to main entrance gate.

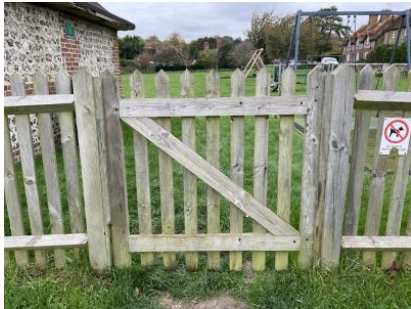
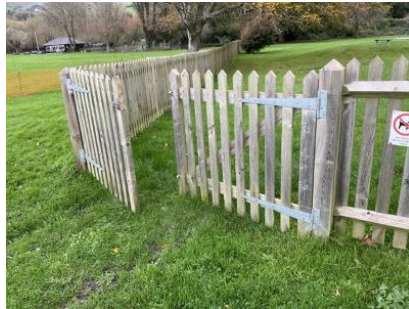
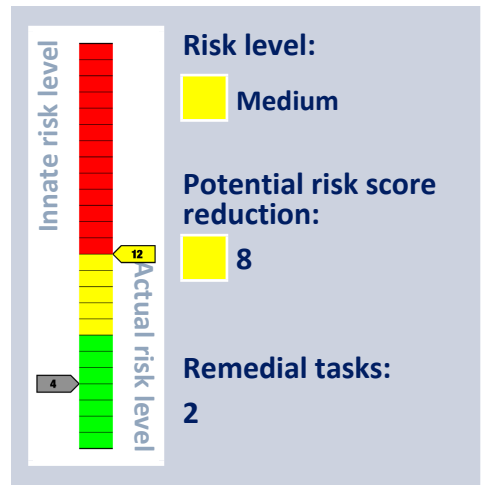
Gates

There is a crushing or shearing point on the side of the gate. Where the gaps reduce to less than 12 mm these have been known to cause serious, permanent injury to children, especially on the hinge side where the leverage forces are significant.

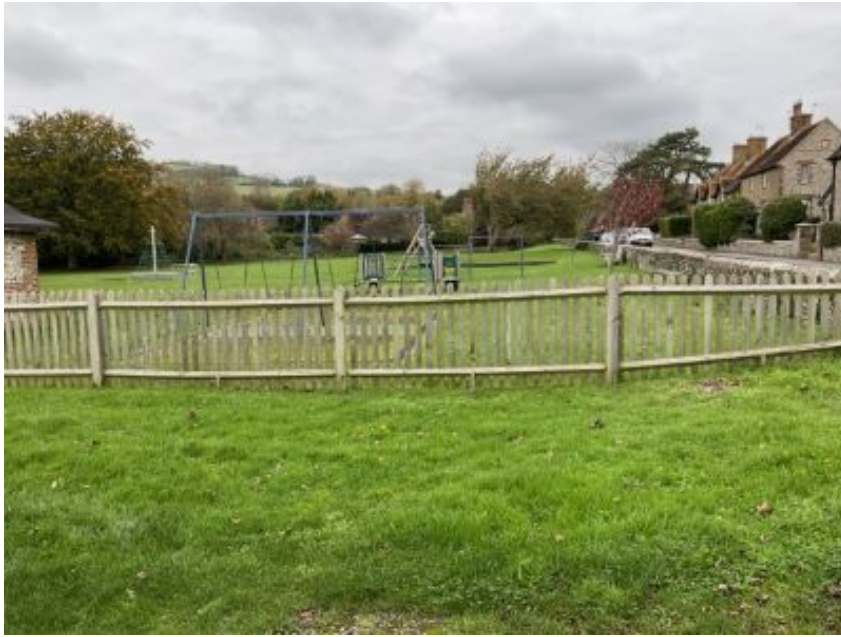
Fencing

Minor repairs are needed.

Replace., Repair.

Repair/replace any broken slats to fencing.

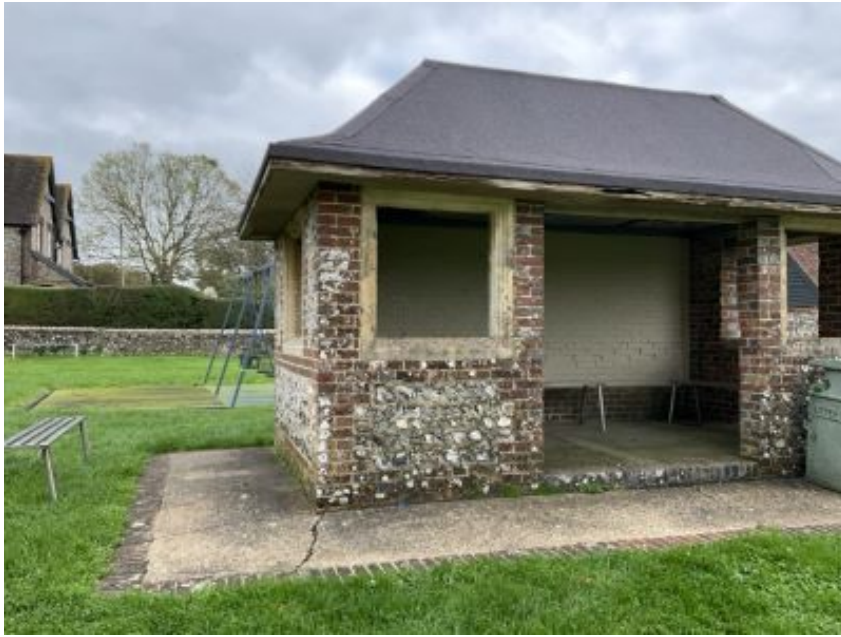
Seating & Shelter

There is significant corrosion on this item.

The surface is cracking.

Fascia is rotting. Replace.

De-scale back to good metal and coat with lead free paint, using appropriate precautions. Repairs may be necessary where corrosion is severe.

Repair.

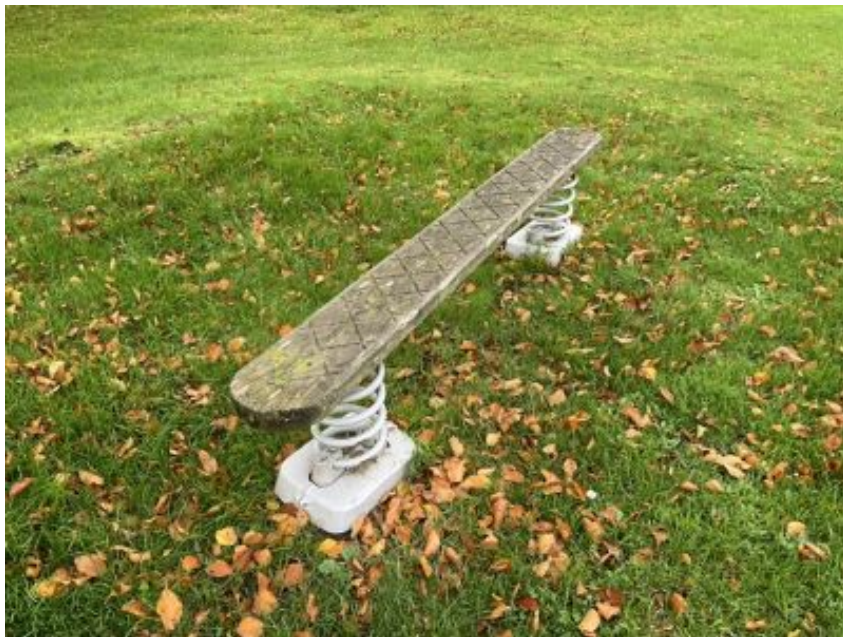
Agility - Wobble Board

The spring is rusty. These have been known to fail without warning, leading to a collapse of the unit.

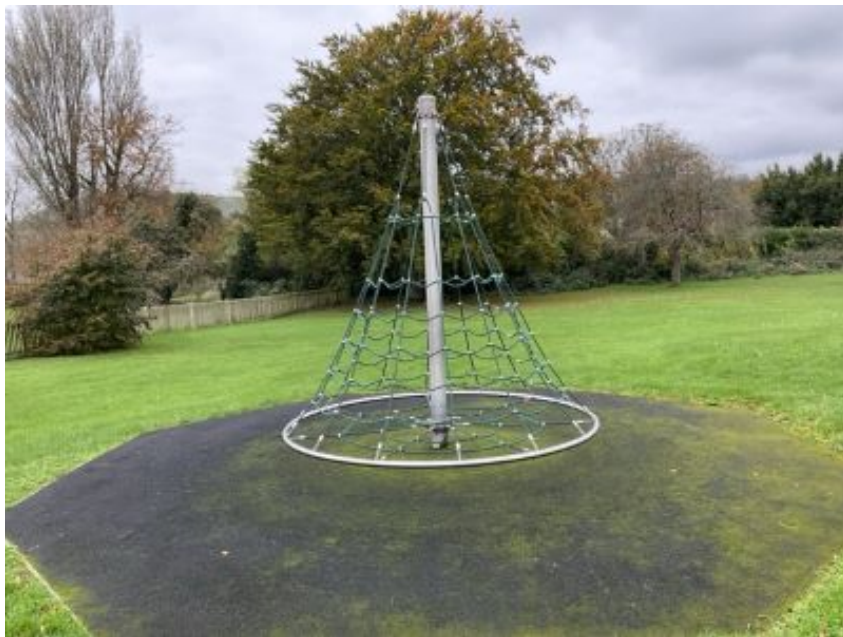
Climber - Rota Web

Algae growth giving slippery conditions.

Bolt(s) missing.

Central bolts missing from top cover. Replace.

Powerwashing is recommended. Care should be taken to ensure that the material can sustain high pressure washing.

Replace missing bolt(s).

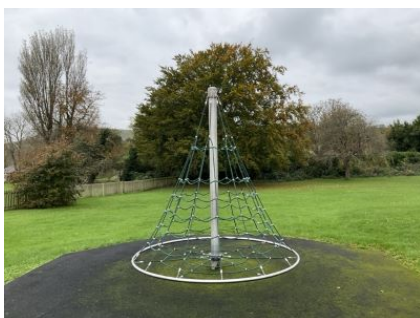
Surface is wearing.

Repair.

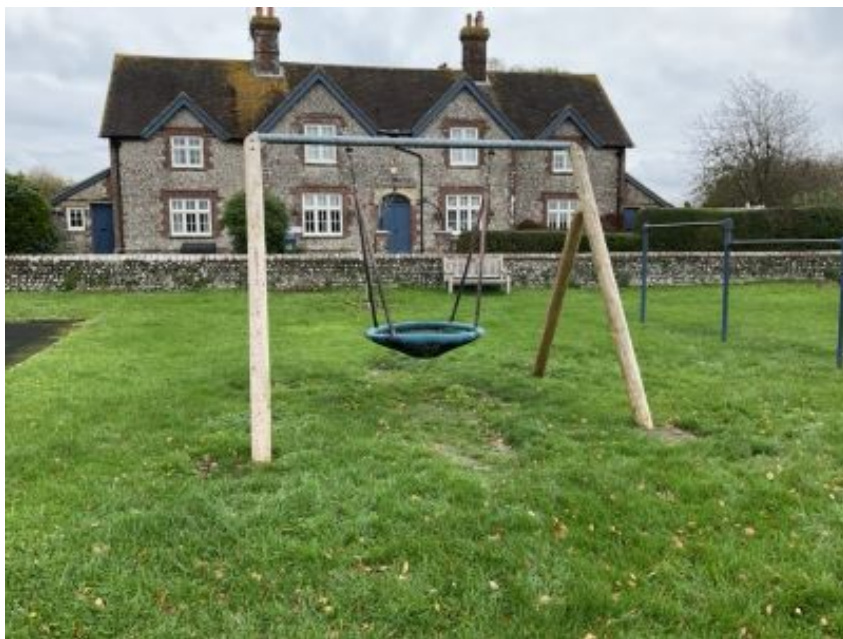
Swing - Basket

Cap missing.

A secondary support device is required to prevent collapse in the event of supporting component failure.

Replace.

Remove chain covers to inspect according to manufacturer's instructions, and replace the covers when done.

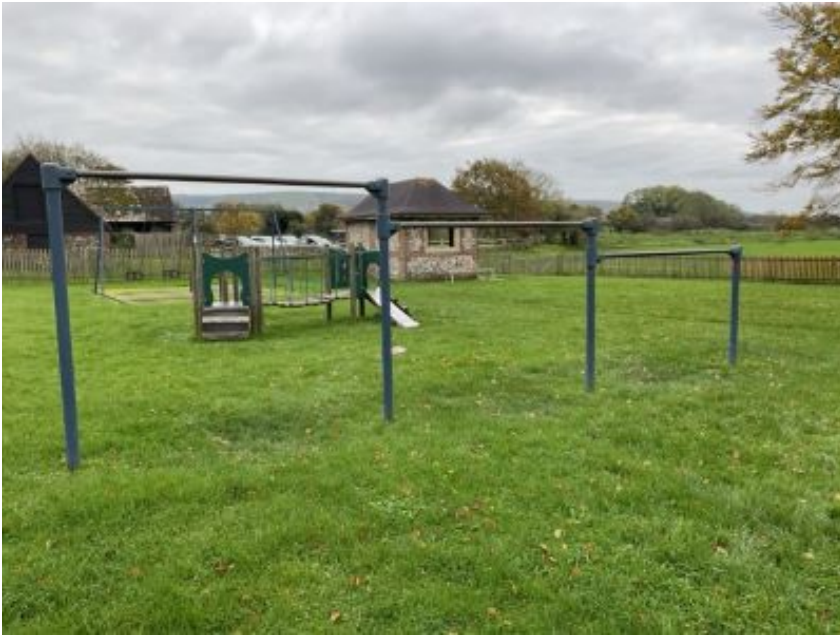
Agility - High Bars - 3 Tier

Paintwork is in poor condition.

De-scale back to good base material and coat with lead free paint, using appropriate precautions. Repairs may be necessary where corrosion is severe.

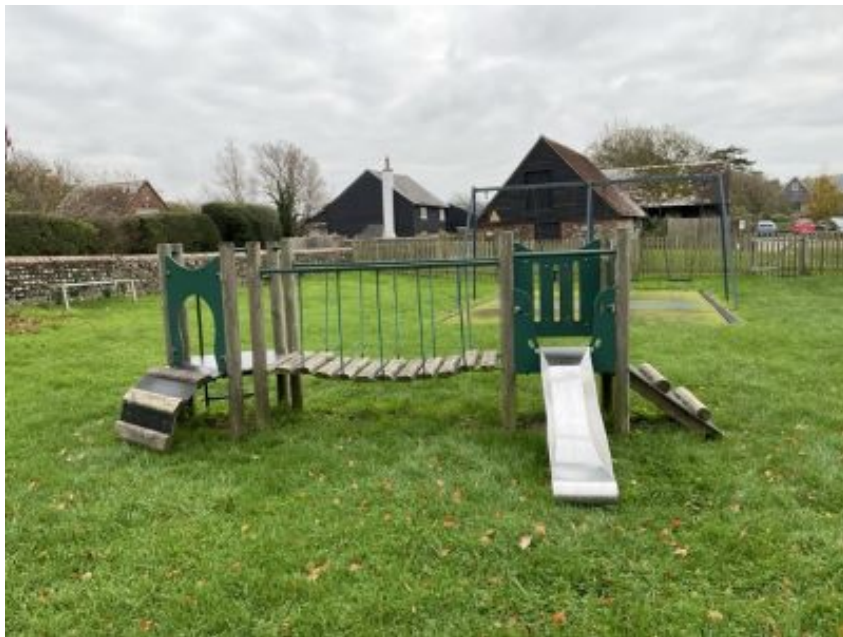
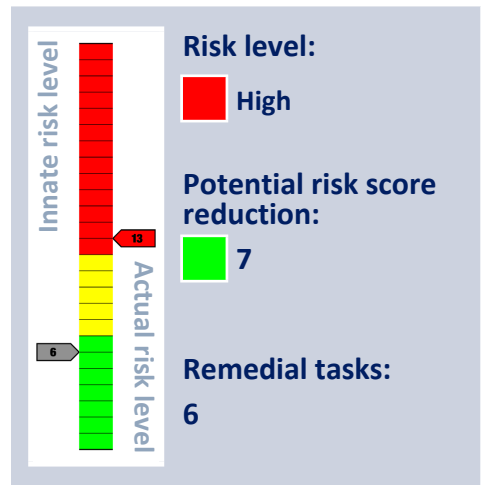
Multiplay - Toddler

Supports are decayed and need to be replaced.

Item is rusting in places.

Programme replacement.

Repair rust damage, dismantle rope to inspect for internal rust. Replace if necessary.

Replace rotten timbers.
